9/8/2023

**John & Kim Britcher**654 Sandra Lee Ct SE  
Olympia, WA 98513**c/o: High Tech Building**Attn: Stefan G. Bull  
625 Acorn Ct SE  
Olympia, WA 98503**Subject: Britcher ADU – Critical Area Ordinance (CAO) Report**  
654 Sandra Lee Ct SE, Olympia, WA

QG Project No.: QG23-150

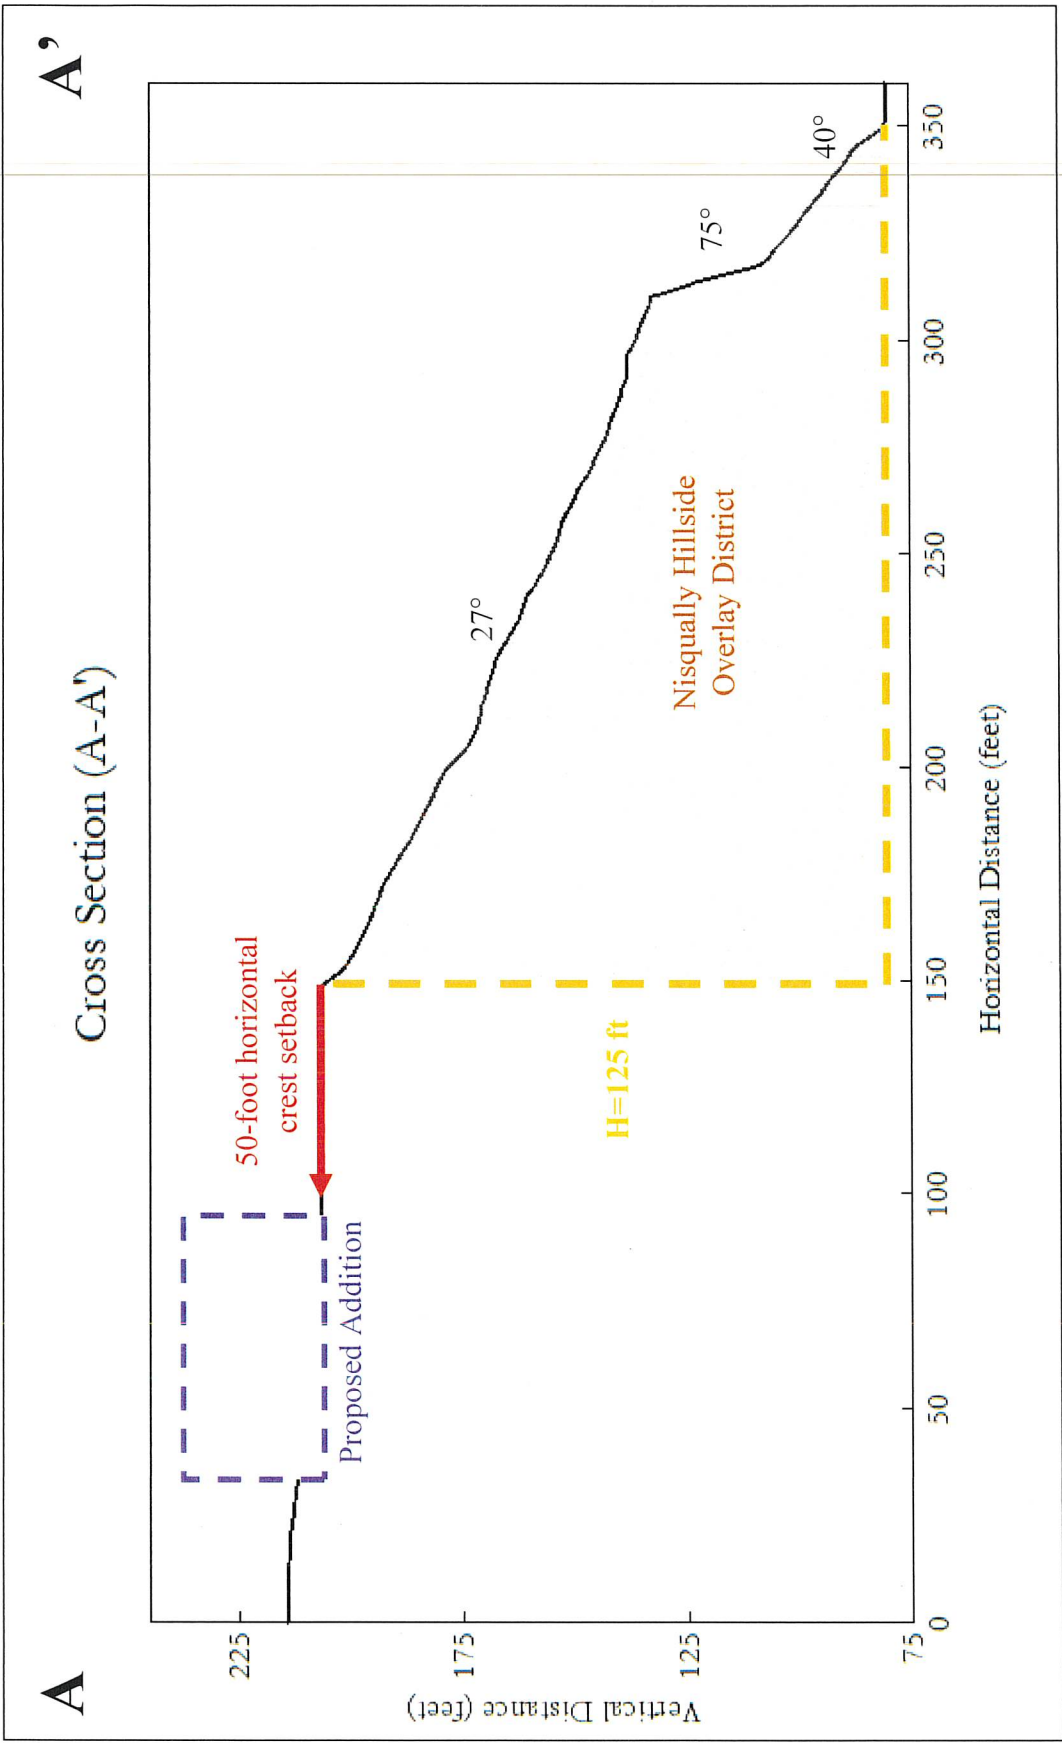
Quality Geo NW, PLLC	Slope Profile A – A' Britcher ADU CAO	Source: Mapped Topo & Land Measurements Scale & Locations are approx. Not for Construction	Figure 3
----------------------	--	--	----------

Considering the inclination and conditions of the lower slope specific setback requirements must be followed for successful construction at this location. The local critical area ordinance delineates minimum slope toe setbacks for slopes inclined greater than 40% (~22°), which may be further reduced upon review by a licensed geotechnical professional. QG's reviewed existing topographic data and general site observations made during our visit to infer general slope face and slope toe

setbacks based on height and inclination of the typical slopes present on the site in proximity to the proposed structure.

**QG recommends that any new foundations be embedded to maintain a minimum horizontal slope crest setback of 50 feet (See Appendix C).** Based on this, the proposed new construction location appears suitable. The setback does not prohibit lightweight surface improvements such as septic, uncovered decks, patios, walkways, landscaping, pathways, etc (if approved by the project engineer). QG does not recommend reducing the setback unless further site-specific foundation design efforts are undertaken to ensure building and slope stability is maintained.
