Phase I – Reconnaissance Evaluation

Carlyon Beach/Hunter Point Landslide

Thurston County, Washington

March 18, 1999

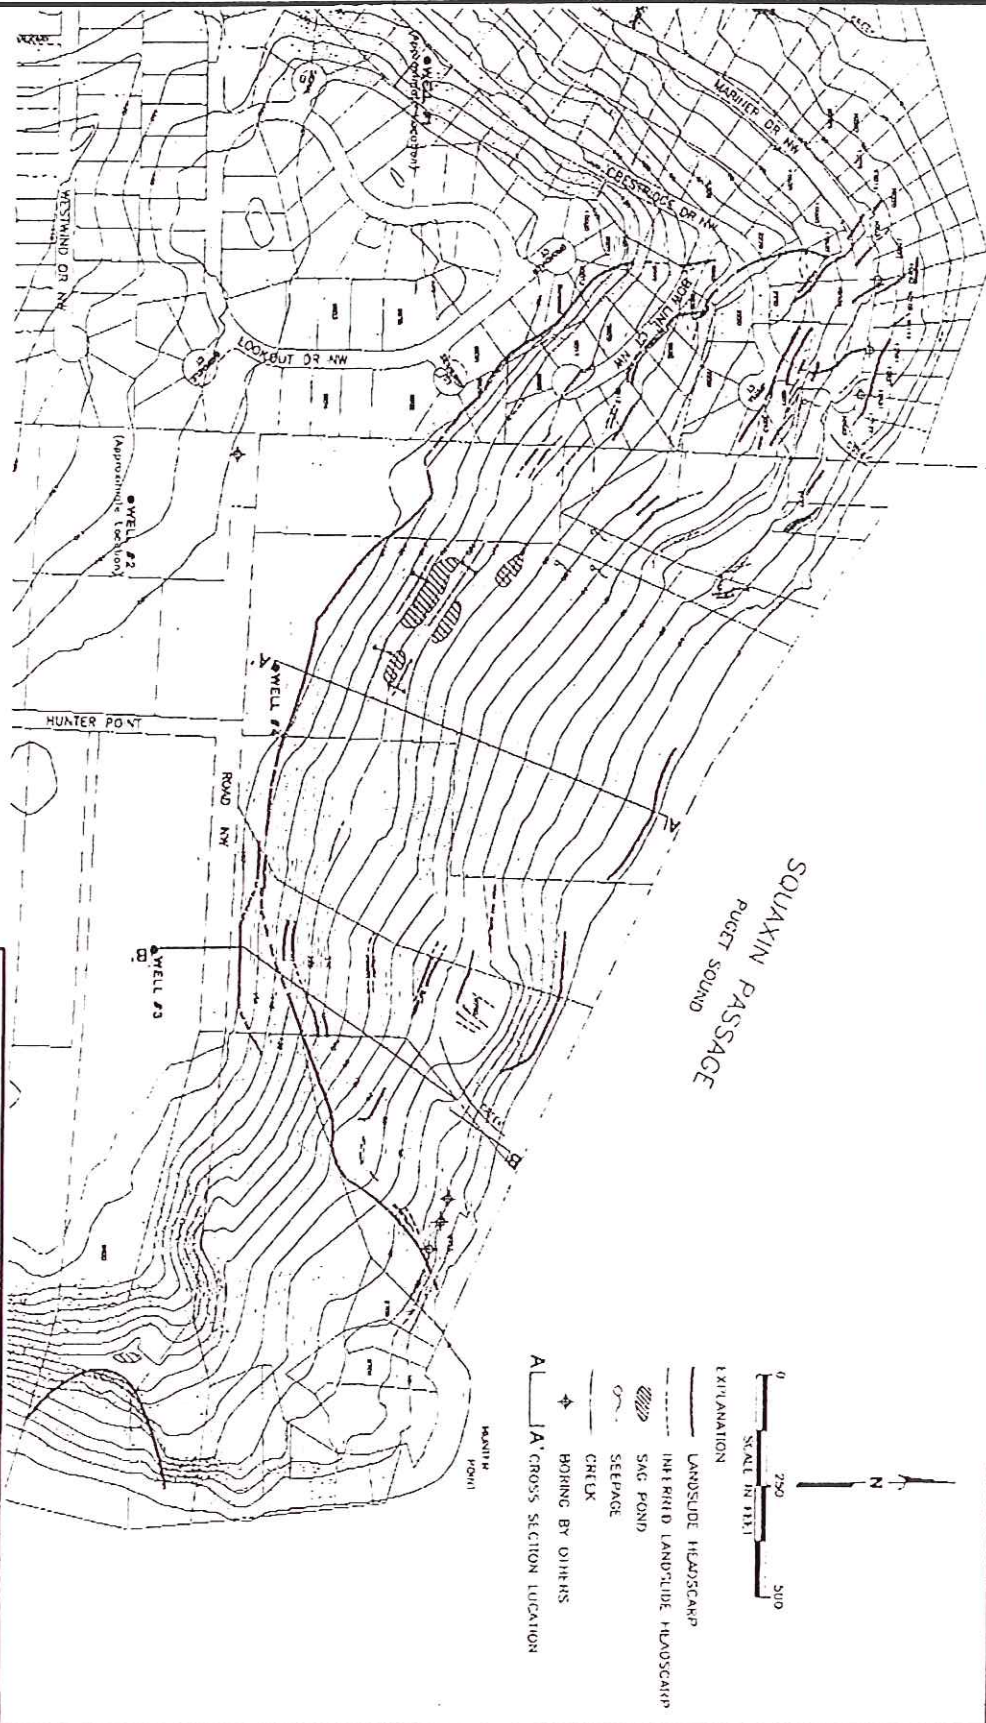
SITE PLAN
 FIGURE 2

The headscarp of the slide currently threatens the integrity of the eastern end of Hunter Point Road and access to several residences in the Hunter Point Community. The current known limit of the landslide mass based on surface features is shown relative to surrounding physical features on the Site Plan, Figure 2.

A steep slope is located along the south limit of the landslide. This slope is approximately 15 to 25 feet high and typically inclined at 30 to 40 degrees. Recent displacement near the top of this slope has created a near vertical headscarp ranging from 1 to 7 feet in height. This steep slope extends both east and west of the currently active landslide area as shown in Figure 2.

conducting surficial geologic reconnaissance. Water well reports were reviewed for wells located at 2417 Crestridge Drive Northwest, 9634 Hunter Point Road, 9731 Hunter Point Road, and a location between the southern portion Lookout Drive and Hunter Point Road. Three interpretive logs from previously completed geotechnical borings near the east end of Mariner Road were reviewed along with three boring logs from 9710 Hunter Point Road, as shown on Figure 2.

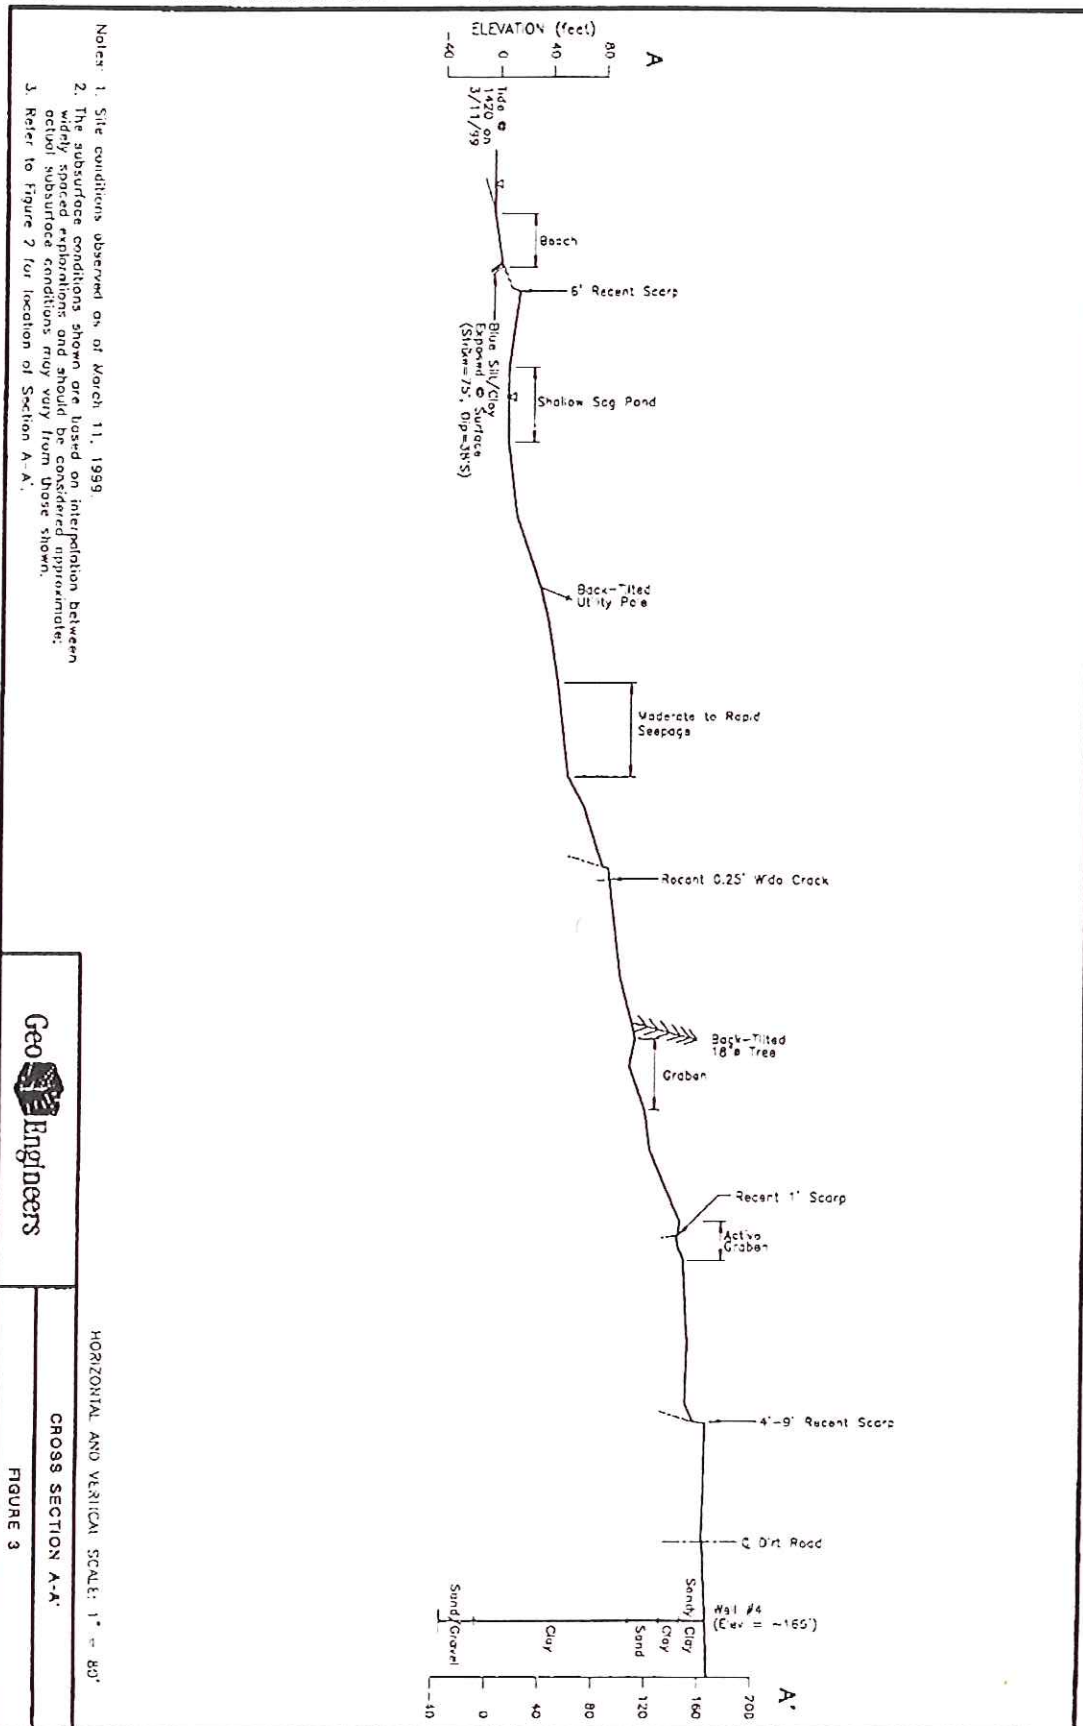
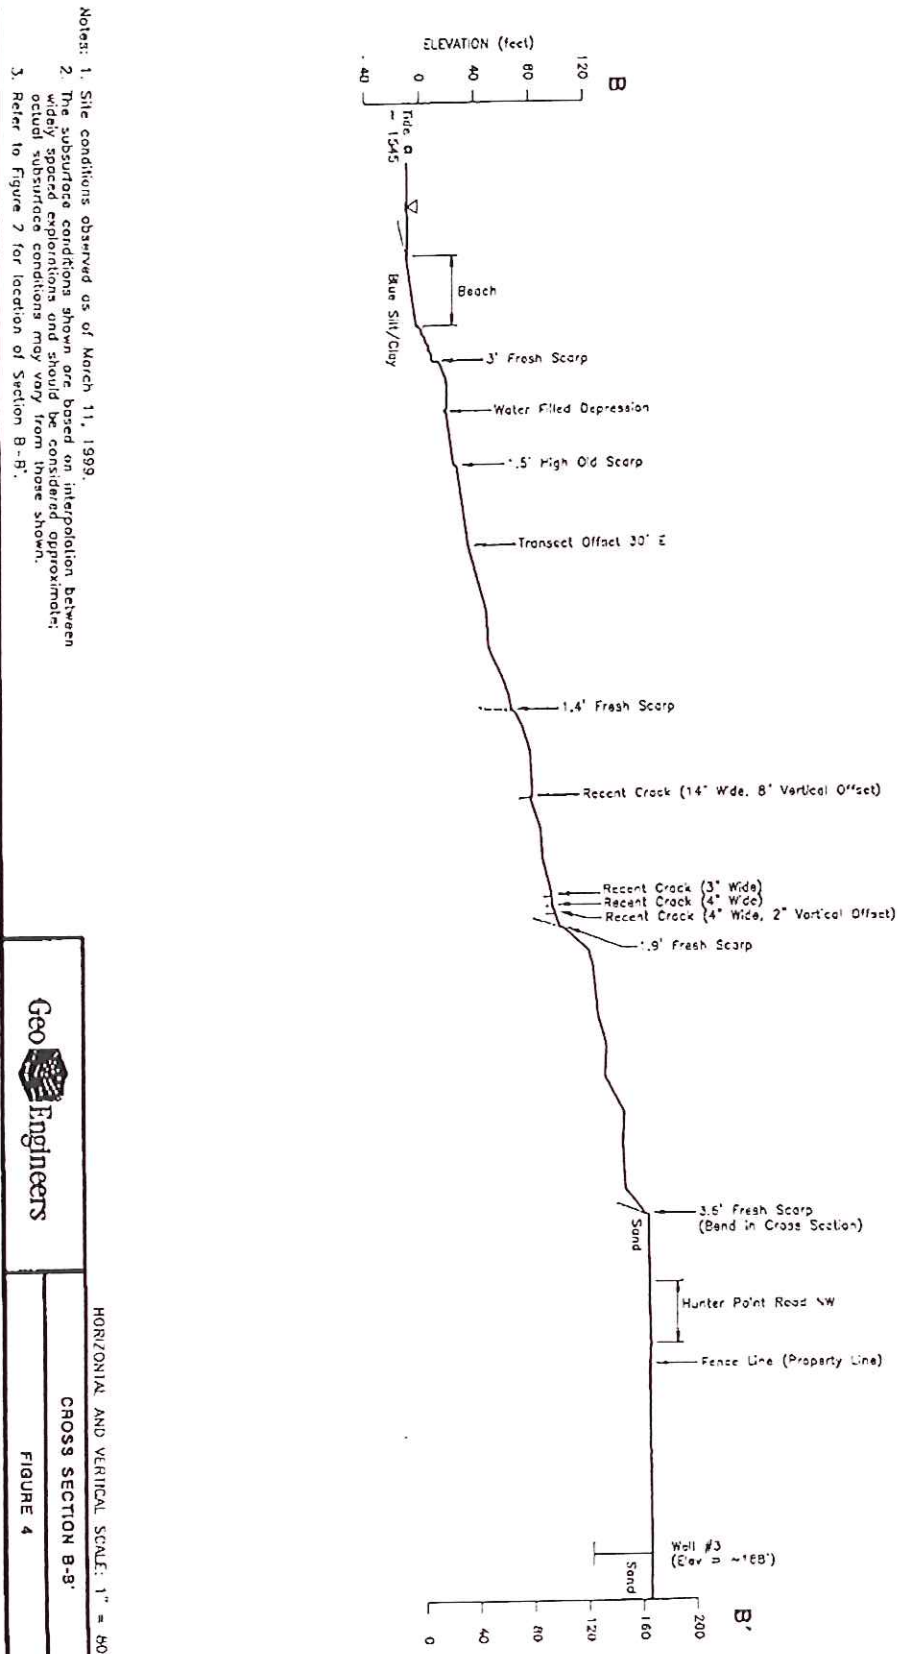
Well locations are shown in the Site Plan, Figure 2. Stratigraphy for selected wells is shown in Cross Sections A-A' and B-B', Figures 3 and 4, respectively.
