MEMORANDUM

Date: March 2, 2009

From: Mark Biever, L.P.G., L.P.E.G. Water Resources Unit
Nadine Romero, L.P.G., L.P.H.G. Environmental Health

Subject: Rock Candy Mountain Landslide - Kennedy Creek North Fork, January 9, 2009

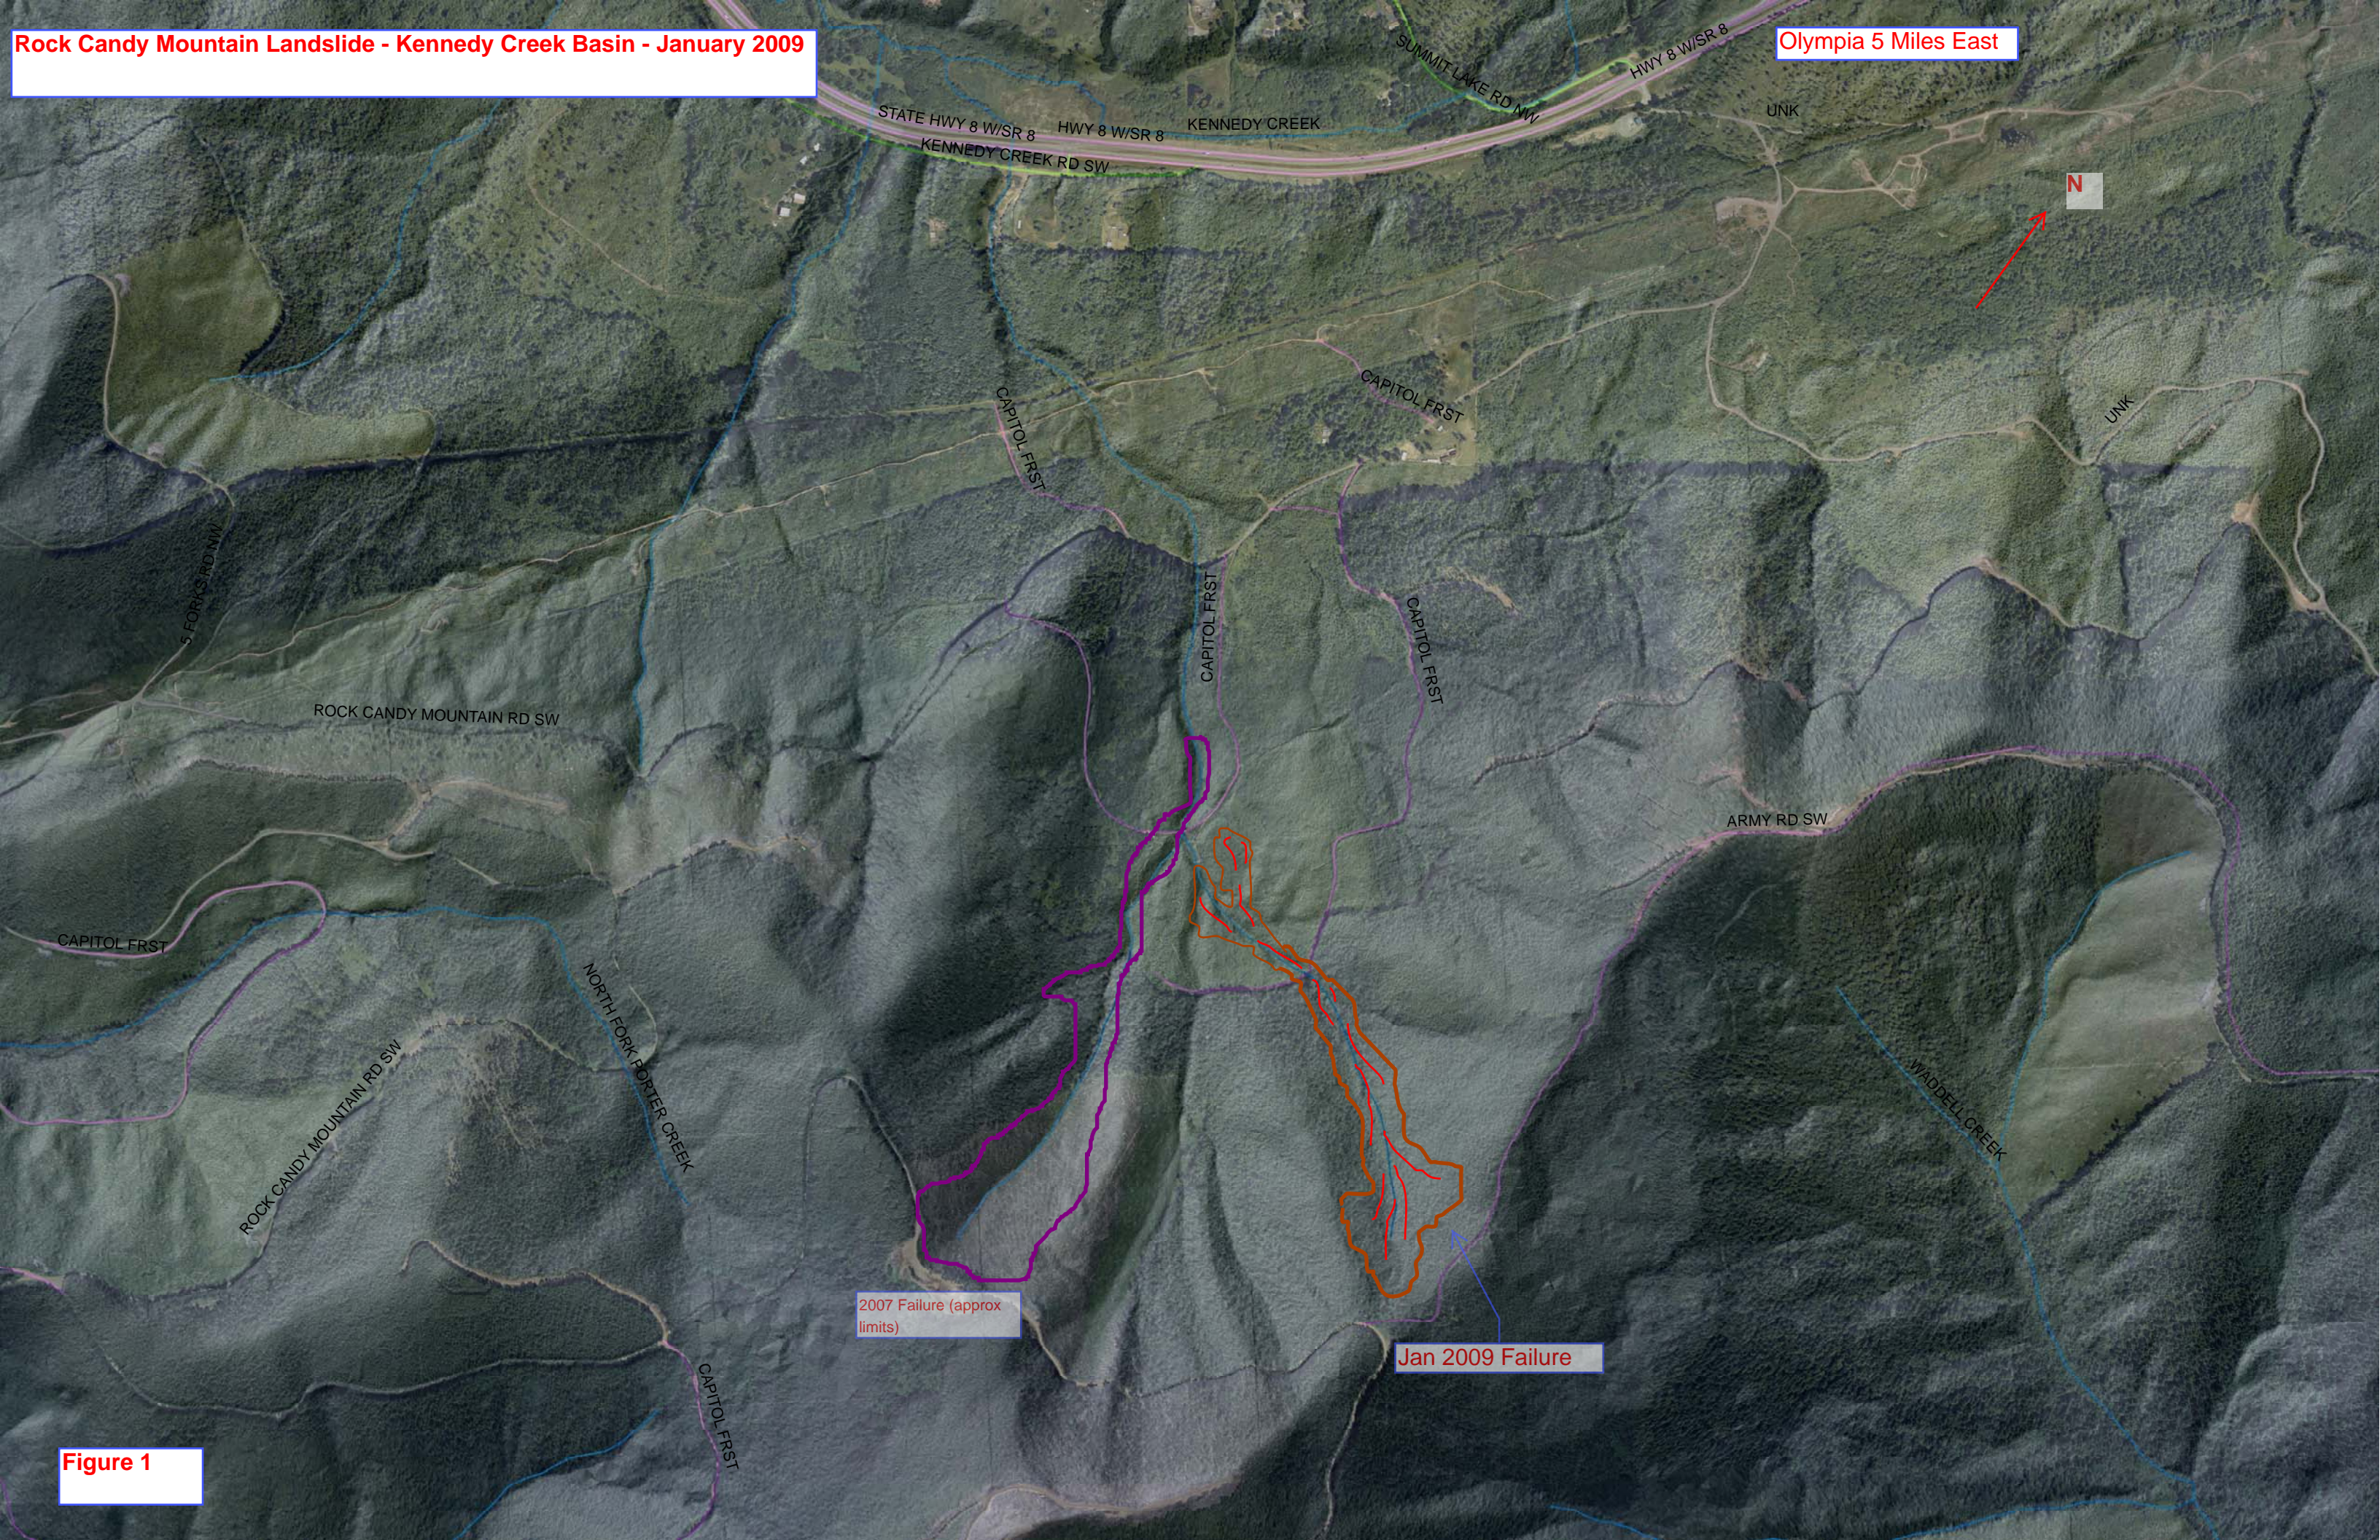
Figure 1

2007 Failure (approx limits)

Jan 2009 Failure

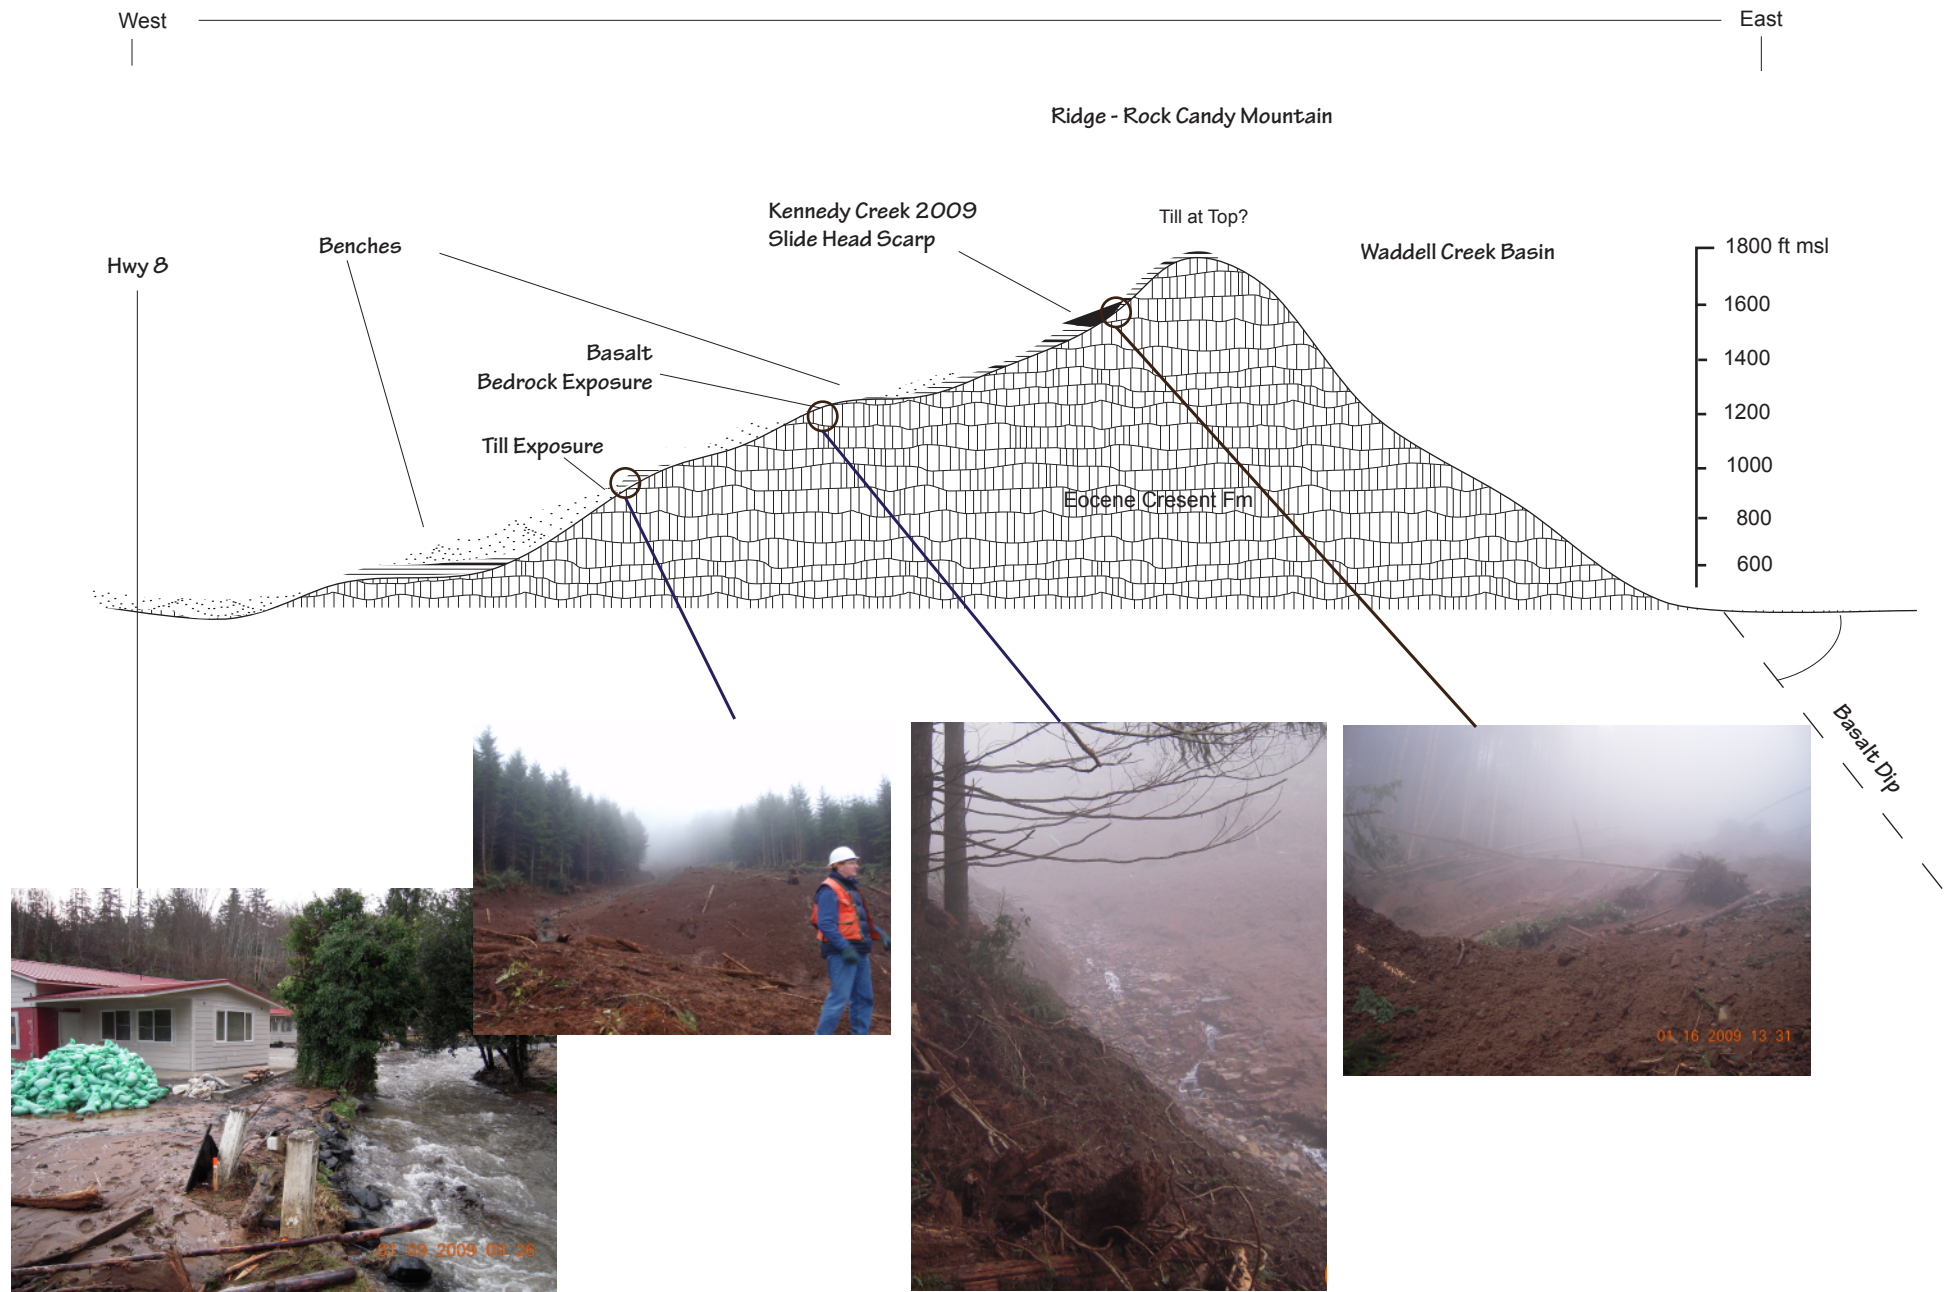
Figure 2 - January 9, 2009 Landslide - Kennedy Creek Uppermost Basin - Rock Candy Mountain

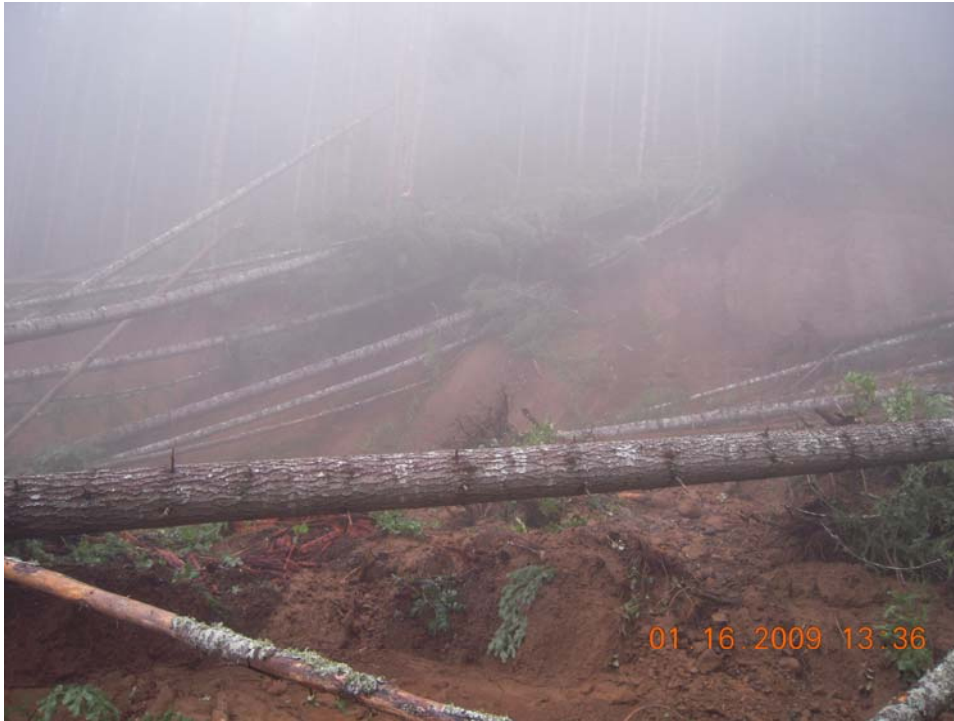
January 2009 Landslide Head Scarp in mature forest. Approximate El.1600'

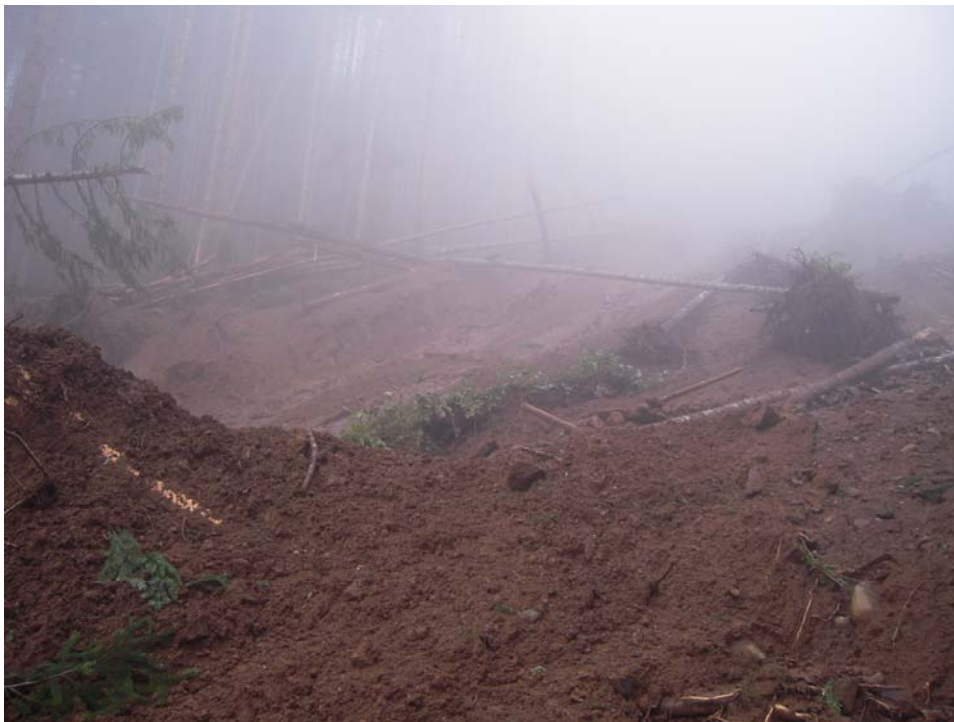
January 2009 - Upper portion of the slide (1400 - 1500'). Blocks and debris piles

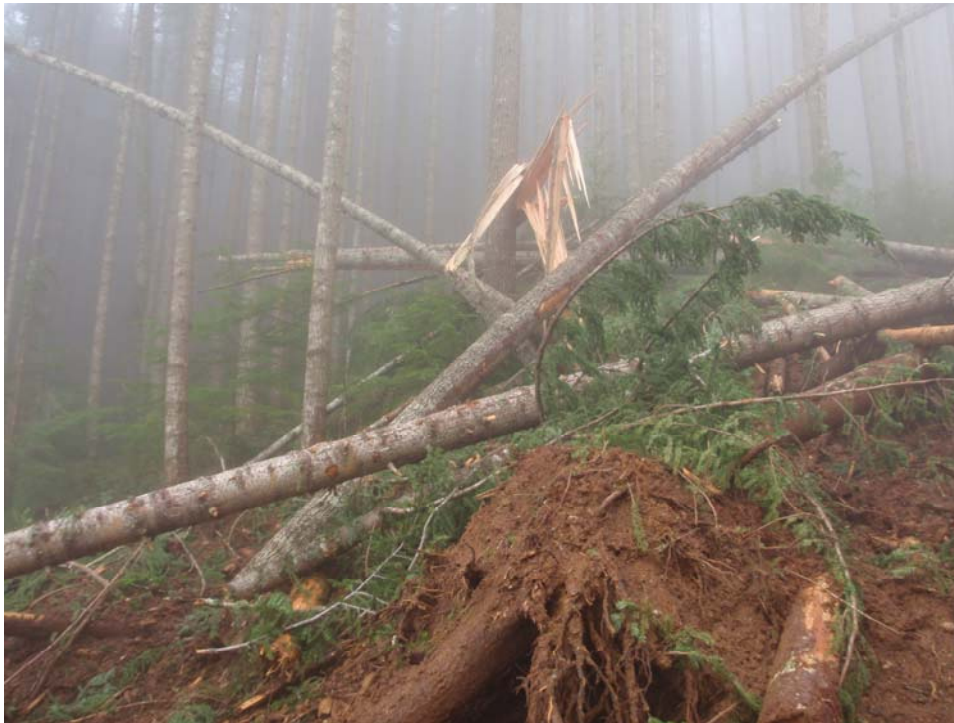
January 2009 - Middle Portion of the slide (1100 -1300'). Increasing velocity splinters trees. Begins the debris flow stage near this elevation.

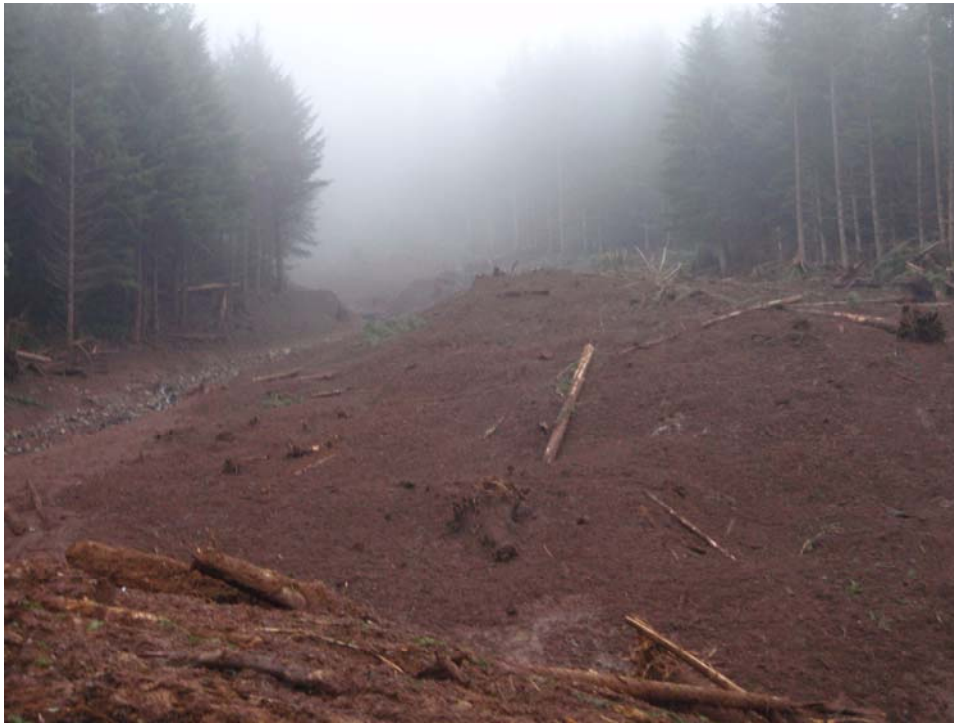
January 2009 - Middle Portion of the slide (900-1200') Looking upslope the path of the slide debris is apparent and the transition to debris flow/torrent has occurred. The forest has been leveled in the path of the debris

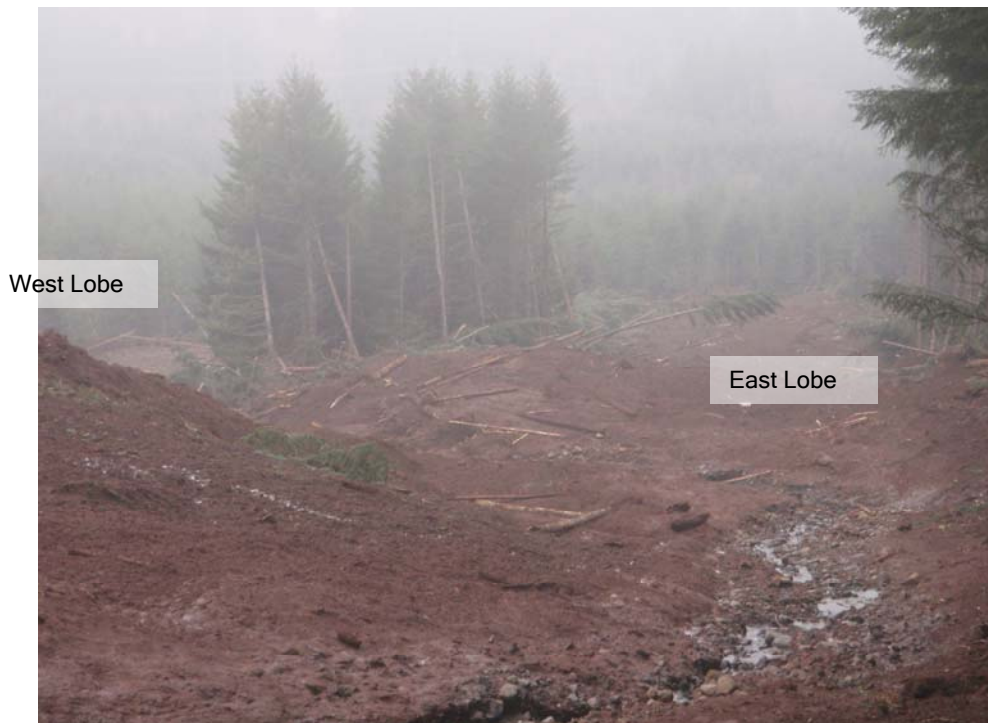
Additionally, looking at the damage pattern caused by the east lobe of the slide suggests that the material had enough kinetic energy, and fluidity to enable it to "slosh" out of the stream channel that generated it, over a small ridge, and through approximately 1500 lineal feet of second growth forest. The width of the east lobe ranges from 300 to 400 feet across at its widest point. The debris shattered and toppled every tree in its path and buried the forest floor in two to six feet of mud and debris. The violent nature of the damage, even to large trees, suggests that the flow material had an impressive amount of energy when it plowed into the forest. The material in this lobe finally came to rest and "deflated" giving up its vast amounts of turbid water into a small tributary. The water then proceeded downslope choking DNR road culverts with debris.

January 2009 - Lower Portion of slide. This stage (~ El. 900') the movement is rapidly flowing debris. Two Lobes diverge from the parent channel. East Lobe (right of tree island) jumps a small hill and slams into forest. Velocity is very high at this point. Debris travels over 1500 feet into forest destroying everything in its path. West Lobe remains in the parent channel.

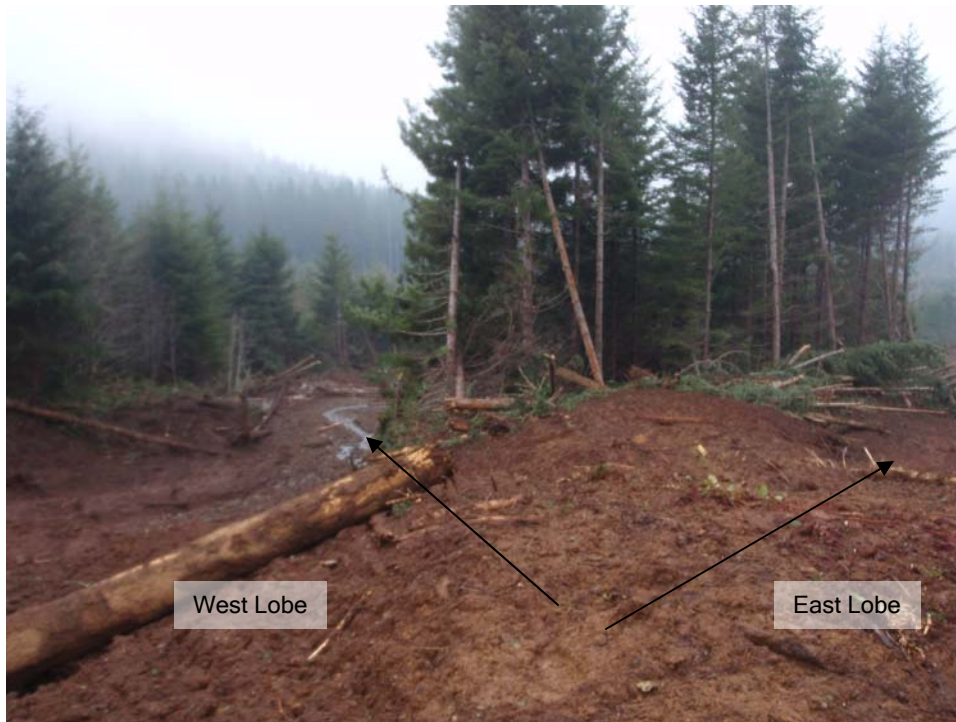
The second lobe of this debris flow (West Lobe) remained in its channel of origin and gradually depleted its energy in a much less violent fashion than the east lobe. It ultimately released its water into the Upper Kennedy Creek system that took the brunt of the 2007 debris flow.

January 2009 - Divergence of the two lobes of the debris flow. Channel on the left is the channel of origin.

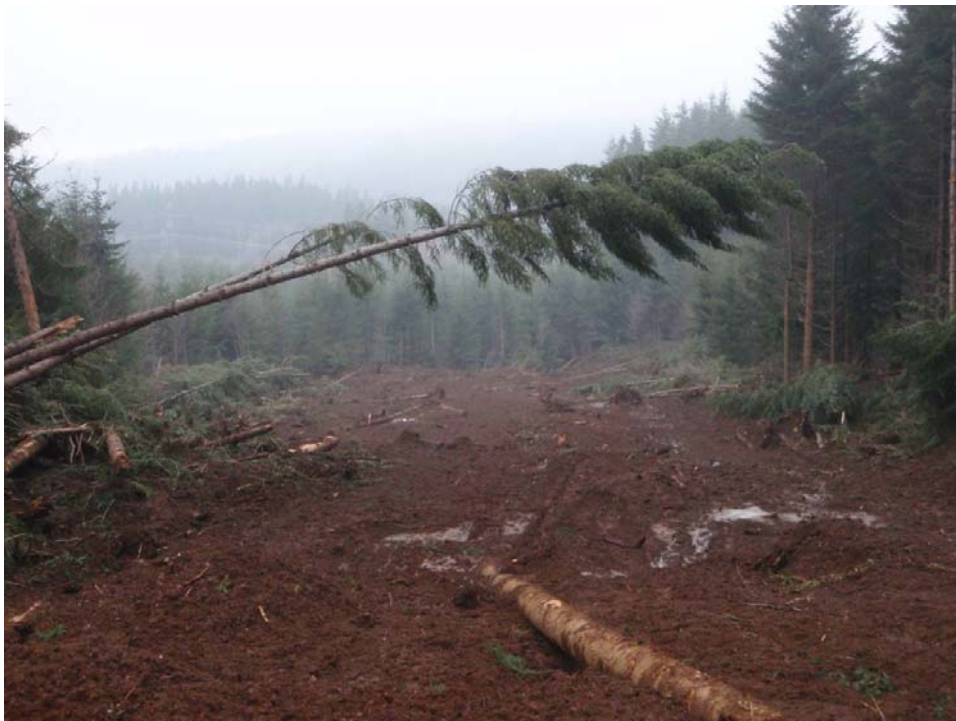
January 2009 - East Lobe of the debris flow. Rapidly moving debris plowed through the existing forest before coming to rest 1500 feet from the location this photo was taken.

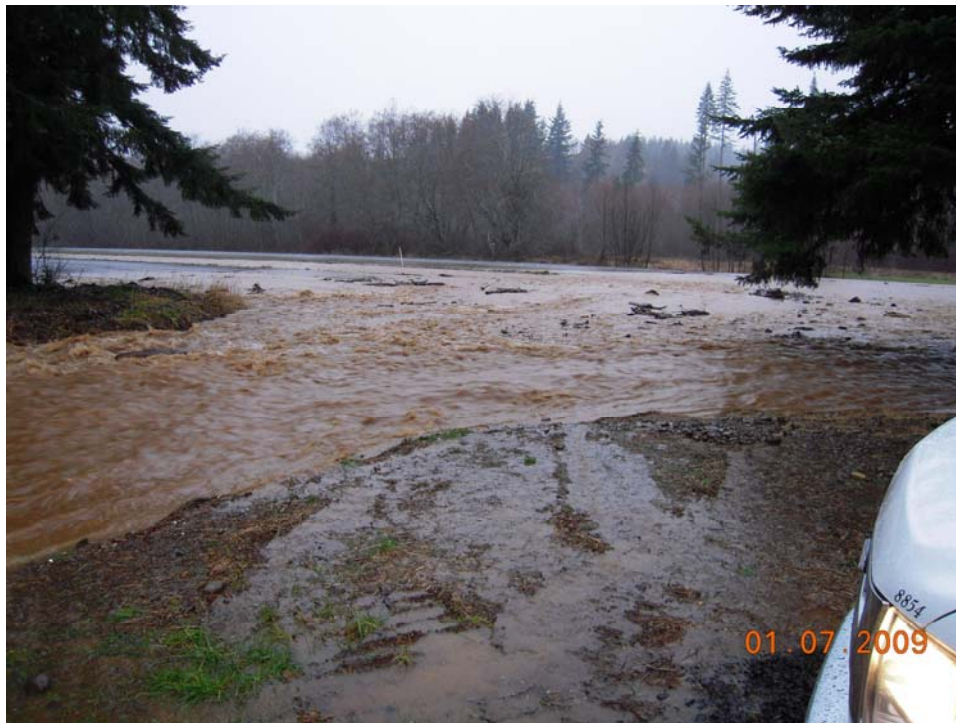
The debris-laden water from this portion of the slide recombined with runoff from the east lobe of the debris flow and continued all the way to State Highway 8. The combined runoff clogged every culvert on its way to Kennedy Creek and overtopped the County road and State Highway 8 resulting in significant maintenance work and a possible redesign of the Highway. Both roads were closed to traffic for several days. A similar occurrence happened in 2007 in which the Ranch House BBQ Restaurant was severely damaged. No injuries were reported in either event.

January 2009 - Kennedy Creek at the Ranch House BBQ restaurant. The Thurston County Kennedy Creek Road is the roadway in the forefront. State Highway 8 is the roadway in the far background. Both roadways were closed for two days for debris removal and water over the roadway.
