Thurston County Government

#### Shoreline Master Program

Review of Select Proposed Shoreline Environment Designations (SEDs)

Andrew Deffobis, Interim Senior Planner 16 March 2022

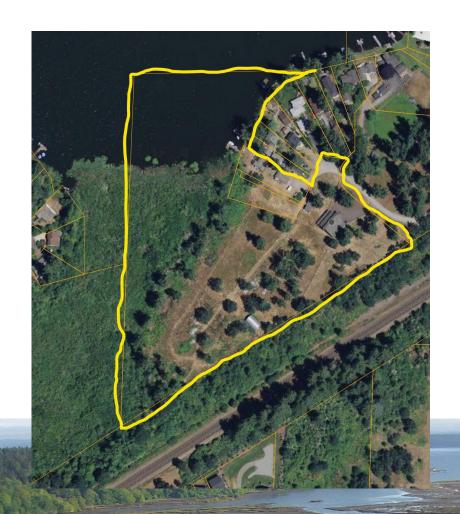
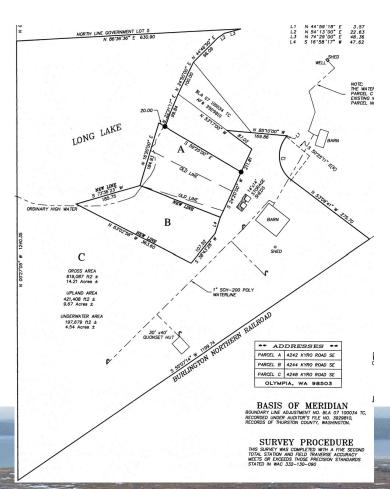
## LLO-4-5, LLO-5-6 (Kyro Rd.)

Left: extent of subject area, highlighted in yellow

Right: Boundary line adjustment map showing new parcel configuration

- The 3 parcels in question occur along the LLO-5 reach break
- BLA has been recently performed
- Current SED: Rural & Conservancy
- Proposed SED: Shoreline Residential & Natural
- Citizen Request: Shoreline Residential (Comment Letter 272)

- Portion of area meets criteria for Shoreline Residential – reach break shift can address this
- Gradient of conditions across site, from more developed to more intact, smaller to larger lots
- Area is portion of larger wetland complex that comprises majority of Reach LLO-5—LLO-6
- Lots B & C appear to have buildable area outside SMP jurisdiction, other regulations will apply

- 4242 Kyro Rd. (Lot Á): Extend Reach LLO-4—LLO-5 to include entire parcel, provide Shoreline Residential SED
- 4244 Kyro Rd. (Lot B): Shoreline Residential may be appropriate, given proximity to similar, developed lots
- 4248 Kyro Rd. (Lot C): Retain Natural SED – area within wetland appears largely intact, unmodified, connected to larger wetland feature

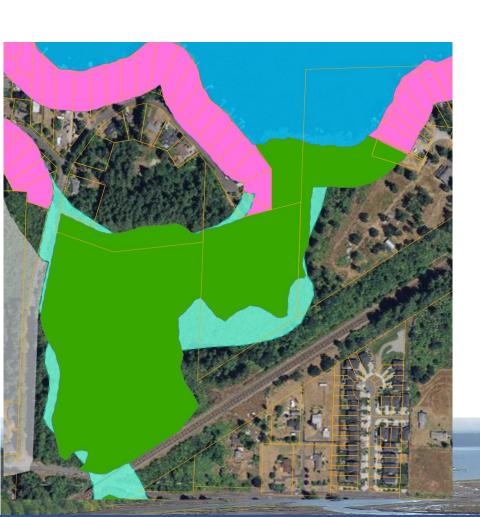
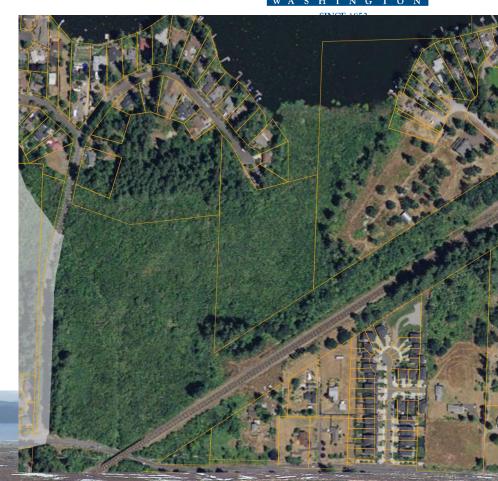
#### Reach LLO-5—LLO-6

Left: Reach LLO-5—LLO-6 general depiction, proposed Natural SED

Right: Reach LLO-5— LLO-6 general depiction, aerial photograph

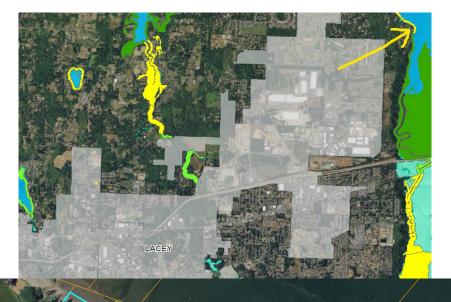
### Nisqually Reach (MNI-21—MNI-22)

Proposed SED: Rural Conservancy

Citizen Request: Shoreline Residential

- Reach contains residential development and some modifications
- Also contains vegetated slopes, mapped feeder bluffs, beaches with some visible large woody debris
- Staff recommendation: Based on review of criteria, retain proposed Rural Conservancy SED (residential area outside UGA/city boundaries with environmental limitations). Rural Conservancy best matches existing conditions.

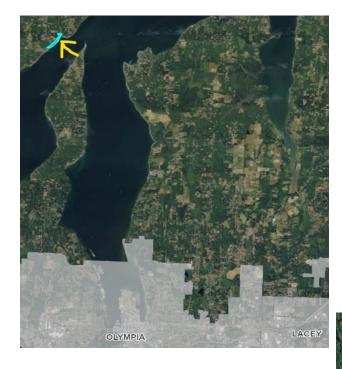
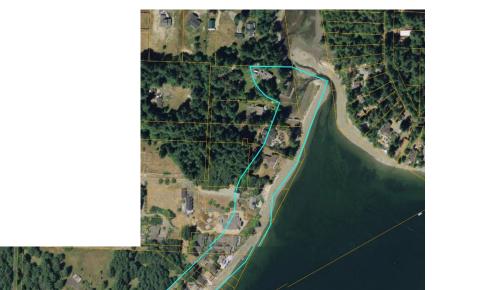
### Eld Inlet (MEL-02—MEL-03)

- Current SED: Rural (Conservancy for 2 parcels and sand spit in north end of reach)
- Proposed SED: Shoreline Residential
- Requested SED: Rural
  Conservancy (for spit and
  1/4 mile south)

- Comment Letter 162
- Cove/sand spit in north end of reach provides significant habitat; a portion has Natural SED proposed
- Adjacent proposed Shoreline Residential SED conflicts with Natural designation, will impact natural areas

- Most of reach has residential development close to the water (within 50 feet)
  - Some lots at north end are less modified, though structures/alterations are present in SMP jurisdiction
- Sand spit area in north end of reach is more intact
  - Sub-parcel property designations are not ideal/consistent with overall update process
  - Area is protected by existing land use regulations
- Recommendation: Retain proposed Shoreline Residential SED for entire reach

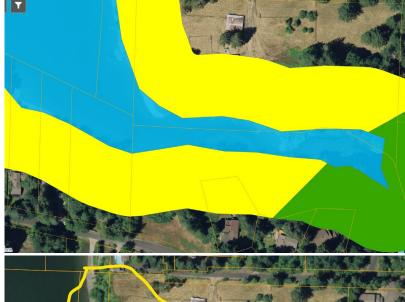
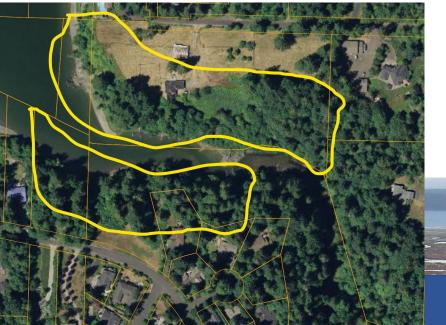
Eld Inlet (MEL-29—MEL-30

- Current SED: Conservancy
- Proposed SED: Natural and Conservancy (toward mouth of cove)
- Requested SED: Natural

- Comment Letter 43
- Green Cove is "a rich and rare estuary, and is essentially wild...from the creek inlet to estuary mouth"
- Important ecological functions could be lost without Natural SED
- Area is unprotected outside the SMP
- Natural SED should be extended to mouth of estuary

- Reach MEL-29—MEL-30 appears to meet criteria for the Natural SED.
- As a whole, reaches MEL-28—MEL-29 and MEL-30—MEL-31 appear to meet the Rural Conservancy criteria.
  - Some areas adjacent to Reach MEL-29—MEL-30 appears intact, particularly in Reach MEL-28—MEL-29.
- Recommendation: adjust reach edges to align with parcels that appear to meet Natural SED criteria

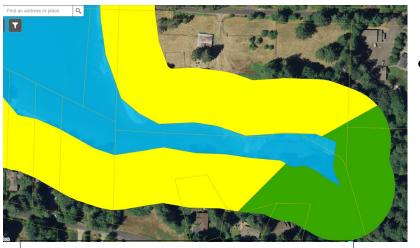
Top image: current boundaries of Reach MEL-29—MEL-30. Bottom image: Staff recommended boundaries.

- Re-align boundaries of Reach MEL-29—MEL-30 to fit existing ground conditions
  - Align Reach Break 29 with edge of HOA-owned parcel
  - Align Reach Break 30 with existing parcel line

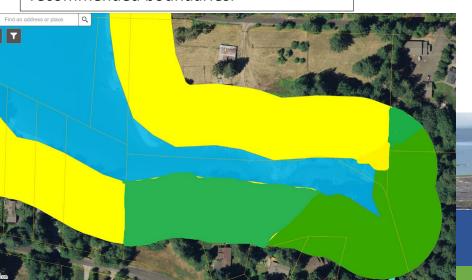
Right: Aerial photograph for reference
