PRYOR PROPERTY

THURSTON COUNTY, WASHINGTON

CRITICAL AREAS REPORT

14 March 2022

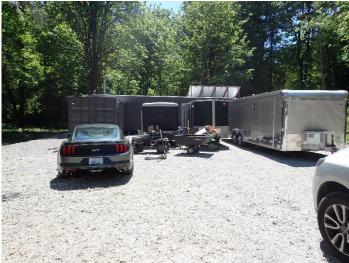
Photo 2. Gravel and shipping containers on subject property

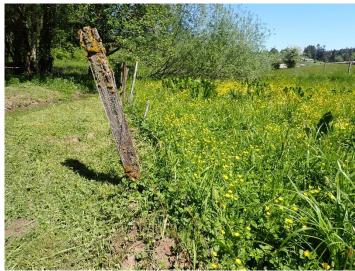
Photo 8. Vegetation impacted left of fence line in Wetland A

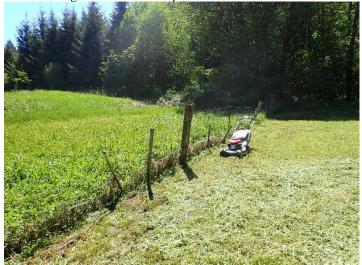
The emergent portion of the wetland has been impacted by clearing the wetland vegetation and dredging of Stream Sa (**Appendix A, Photos 9-11**).

Photo 9. Impacted vegetation in Wetland A will be restored

Restore the wetland and stream to pre-existing conditions and to restore and enhance wetland buffer functions. A planting plan proposes to restore native herbaceous vegetation that occurs in the non-disturbed portion of Wetland A east of the subject property. The seed bank of native plants likely remains in the soils. Thereby, with avoidance of further disturbance and restoration of hydrology, native plants will likely germinate and revegetate the wetland. Wetland hydrology will be restored through installing ten (10) check dams of woven sticks installed to the stream bottom. Check dams will catch sediment flowing downstream restoring channel diversity. The check dams will fill the excavated channel with sediment, restoring channel diversity.

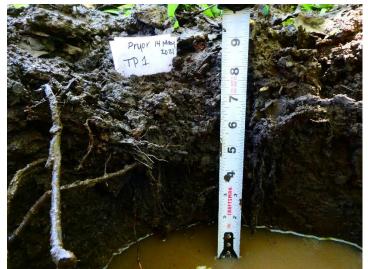
Photo 13. Hydric indication at TP-1

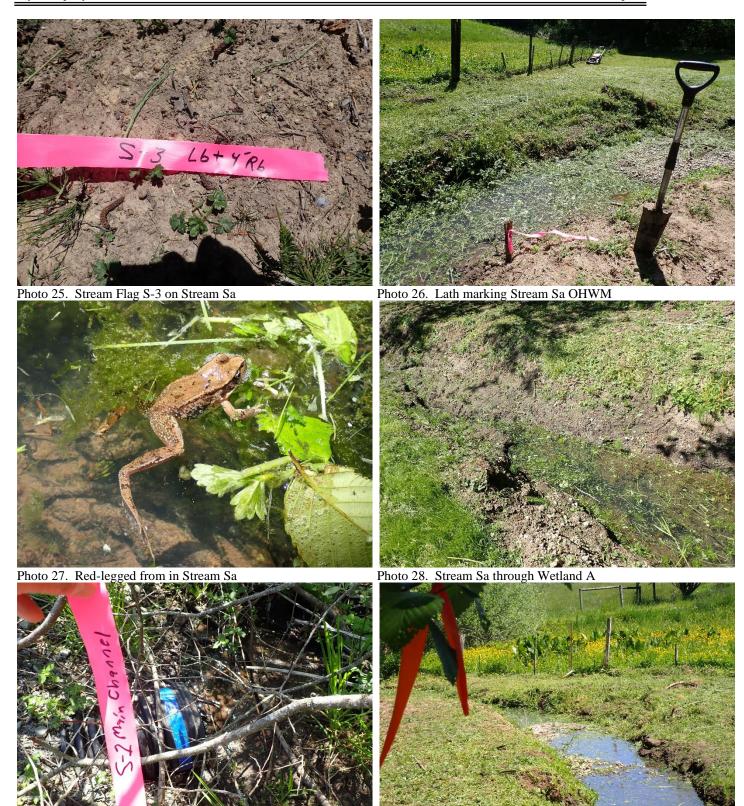
Photo 29. Plastic Culvert at stream flag S-1 main channel

Photo 30. Stream Sa through Wetland A
