October 11, 2022

Report
Geotechnical Investigation and Retention Design
2725 Schirm Loop Road NW
Olympia, Washington
Project No. 2152-001-01

Daniells Property
Geotechnical Investigation Report
October 11, 2022

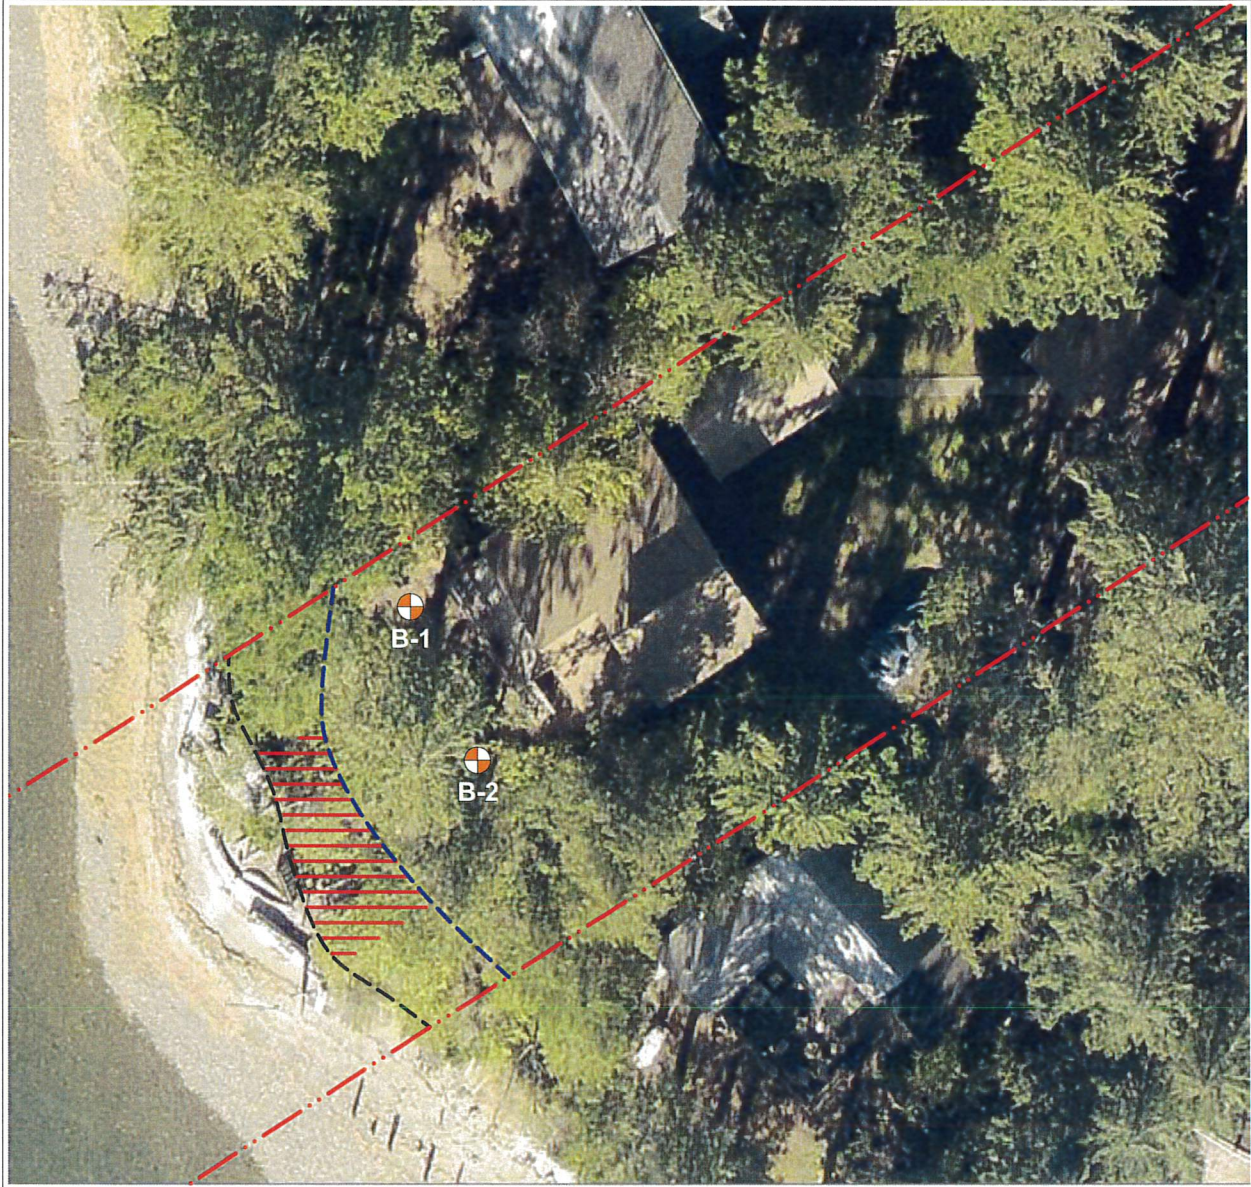
Figure 2
Site Plan

Insight Geologic contracted with Borettec, Inc. to provide drilling services for two borings located adjacent to the area experiencing movement. The borings were drilled using a limited-access hollow stem auger drilling rig. Boring B-1 was located approximately 20 feet northwest of the north end of the soil movement and boring B-2 was drilled in line with the center of the observed soil movement. Both borings were drilled to a depth of 31.5 feet bgs.

APPROXIMATE FAILURE AREA

Insight Geologic is pleased to provide our report of our investigation of subsurface conditions for your property located at 2725 Schirm Loop Road NW in unincorporated Thurston County, Washington. The site location is shown relative to surrounding physical features in the Vicinity Map, Figure 1 and Site Map, Figure 2.

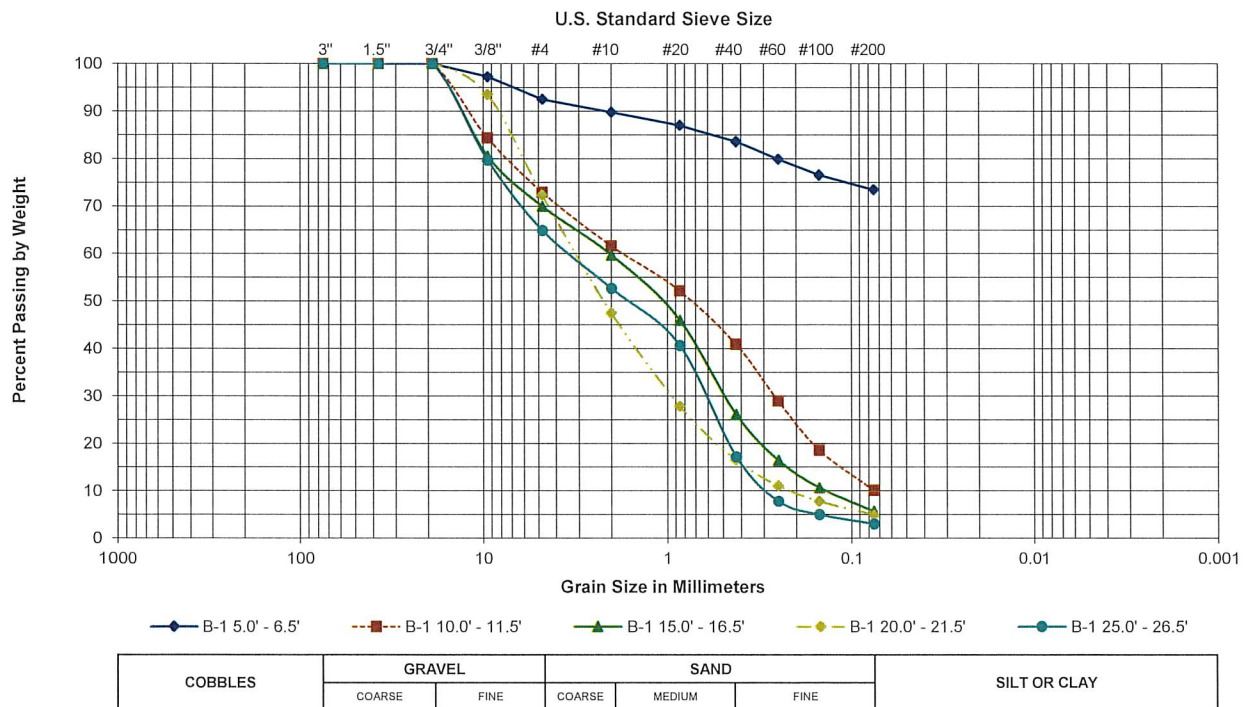
Graph 1
Gradation Analysis Results

We selected seven soil samples for gradation analyses in general accordance with ASTM D422 to define soil class. The laboratory results are presented in Attachment B.
