INSIGHT GEOLOGIC, INC.

September 24, 2018

Report  
Steep Slope/Landslide Hazard Assessment  
Veloni Property  
5725 Sunrise Beach Road NW  
Olympia, Washington  
Project No. 1072-001-01

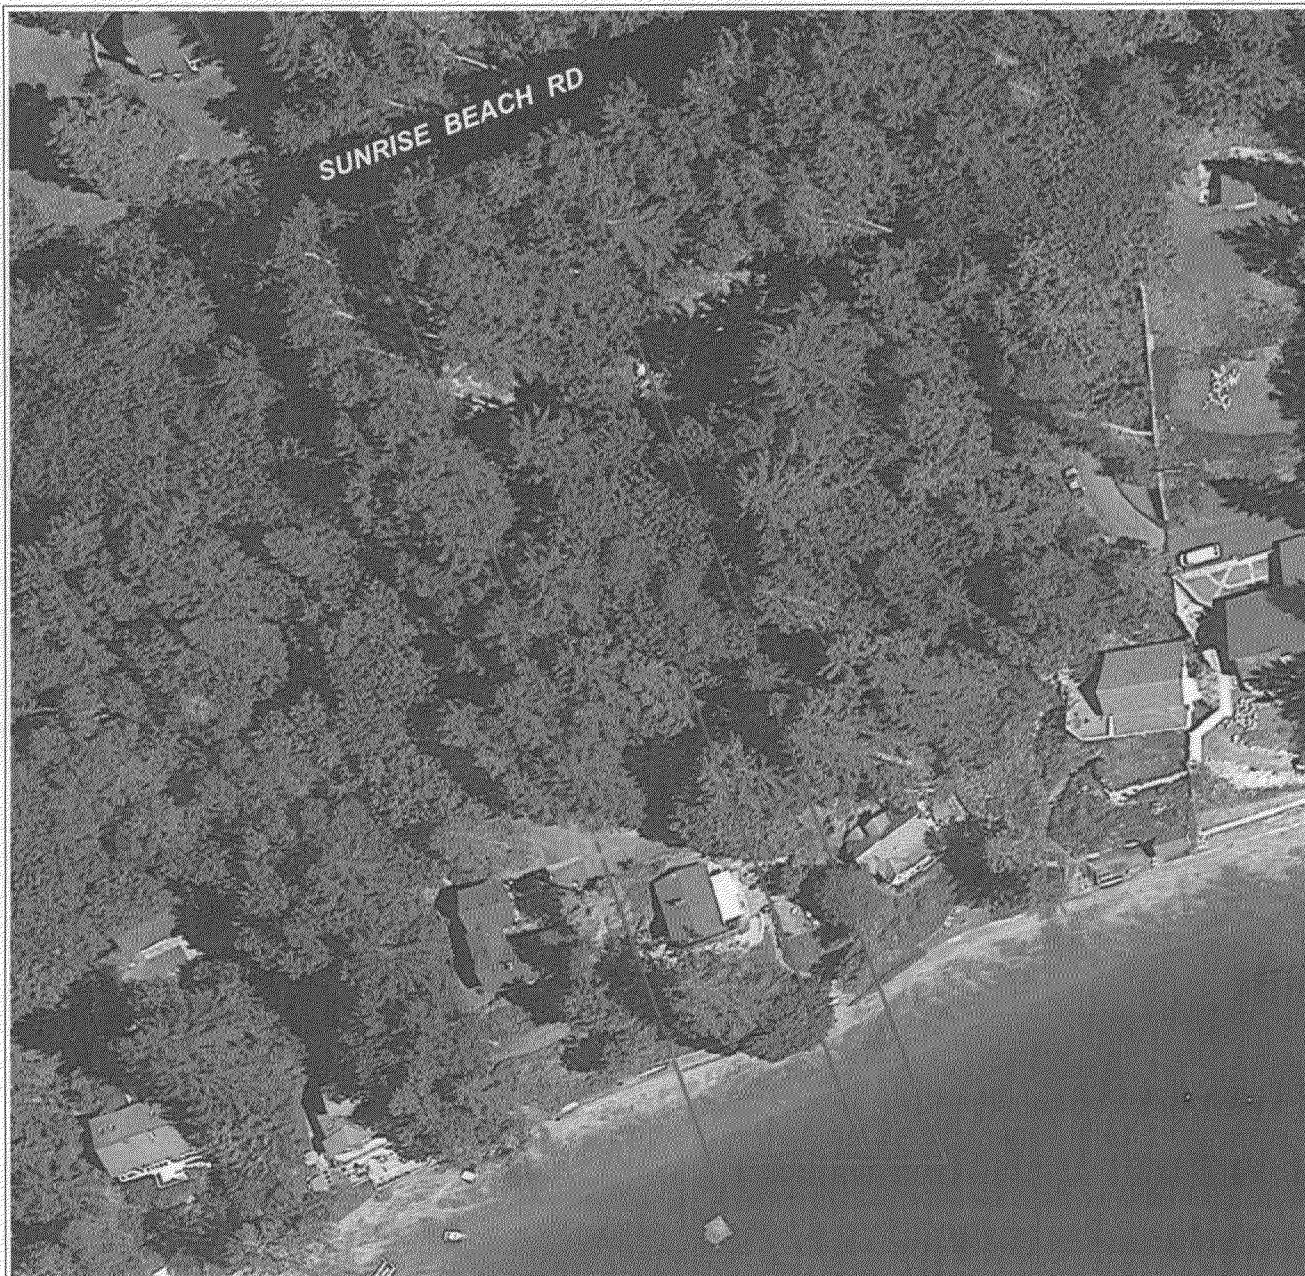
**Figure 2**  
**Site Plan**

Insight Geologic is pleased to provide our report regarding our evaluation of slope conditions at your property located at 5725 Sunrise Beach Road NW in unincorporated Thurston County, Washington. The location of the site is shown relative to surrounding physical features in the Vicinity Map, Figure 1. We understand that the site is developed with a single-family residence and you are planning on a remodel and possible addition to the structure. This steep slope/landslide hazard assessment was requested due to planned activities that will occur within 100 feet of slopes over 15 percent inclination and with at least 10 feet of elevation gain, as required by Thurston County's Critical Areas Ordinance. A site plan is shown in Figure 2.

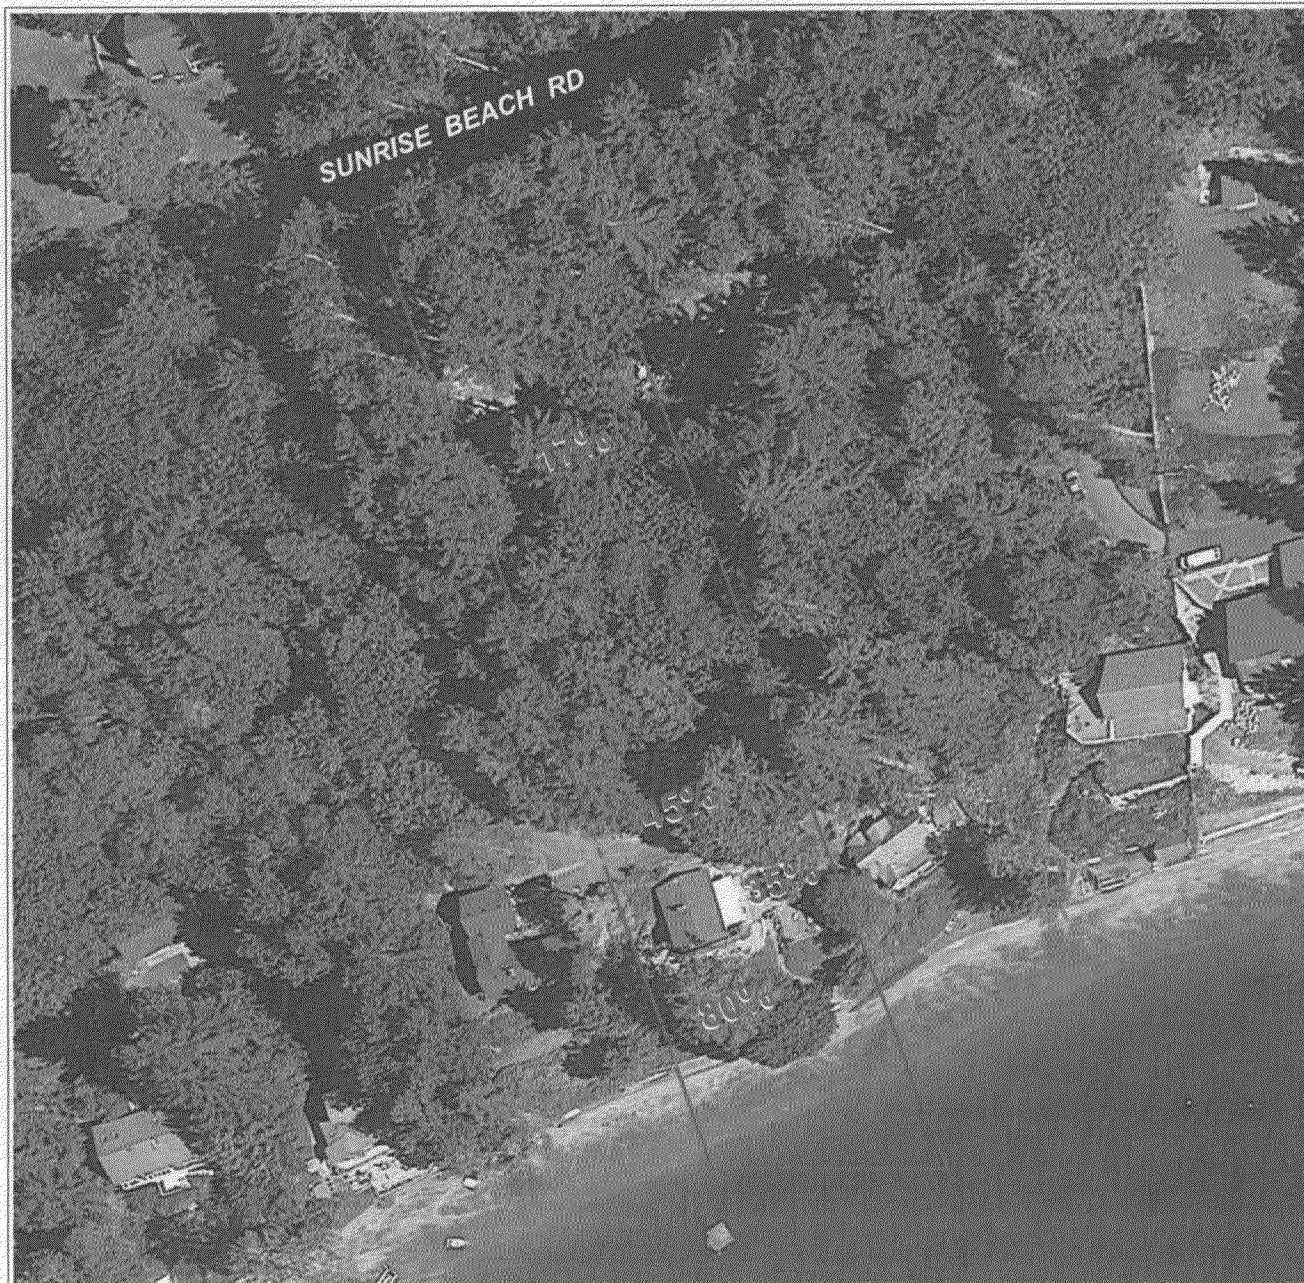
**Figure 4**  
**Field Reconnaissance**

The existing residence is located on a topographic bench at an approximate elevation of 42 feet above mean sea level (MSL) and is located 17 feet from the top of the marine bluff, which descends to the south. The height of the slope is approximately 34 feet, based on our review of topographic information provided by the Thurston County Geodata Center and our site reconnaissance. Based on multiple measurements made using a hand-held clinometer, the steepest slopes are located to the south of the residence with inclinations of up to 80 percent. Slopes located east of the residence have an inclination of 35 percent. The upland portion of the parcel is gently sloping with an overall inclination of approximately 17 percent down to the south. A short slope uphill of the driveway has an inclination of 45 percent, however does not reach a height of 10 feet. Soils exposed along the steep slopes were observed to be very dense sandy soils with gravel and silt that are generally consistent with glacial till.

We did not observe indications of current or past large-scale slope failure such as slump blocks, back-tilted slopes, ponded water or seeps on the property. No geologic contacts which would serve as sources of slope failure were observed. Fir and maple trees growing from the side of the steep slope exhibit curvature of the trunk known as a "pistol butt" and the concrete stairway has minor distressing, indicating likely minor shallow soil creep along the slope. Our field reconnaissance observations are shown on Figure 4.

- The base of footings for habitable structures should be setback from the top of slope equal to the existing building footprint. No further encroachment towards the top of the waterfront bluff shall occur.
- All stormwater drainage, foundation drainage and road runoff should be routed through tightlines to the base of the slope for discharge or to an engineered stormwater system, if available. Collected drainage and runoff should not be allowed to discharge onto the face of the slope.
- Low growing vegetation should be encouraged within 10 feet of the slope face and on the slope face to reduce erosion and increase soil strength resulting from the root systems.
