KYLE AND CHERYL MAZANTI JOHNSON POINT LEASE EELGRASS DELINEATION REPORT

Prepared by Audrey Lamb, Taylor Shellfish Farms July 2019

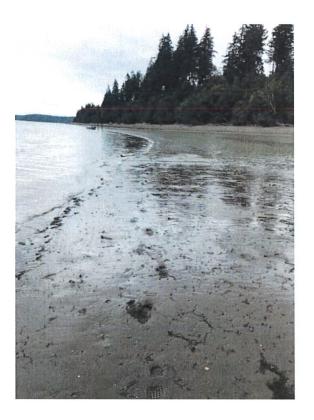
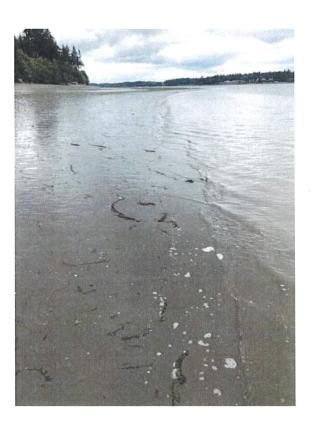
Photo 1 (Left): View of project area looking south (47.167, -122.827). Photo 2 (Right): View of project area looking north (47.168, -122.826).

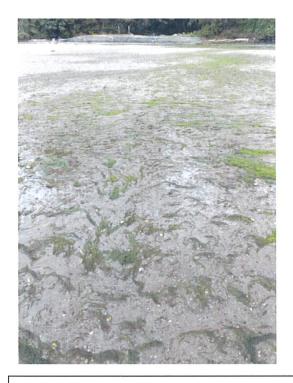
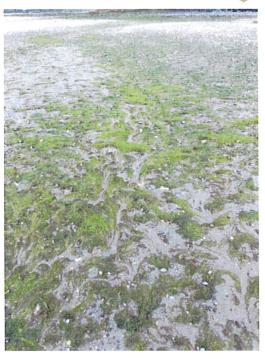
Photo 3 (Left): Northern end of project area (47.167, -122.826). Photo 4 (Right): Closer look at northern end of project area (47.167, -122.826). Vegetation in photos 3-4 is *Ulva spp*.

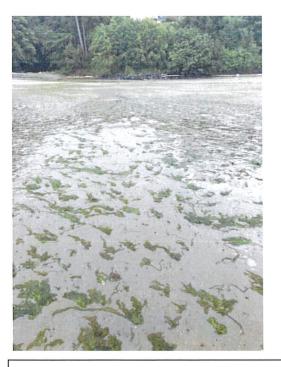
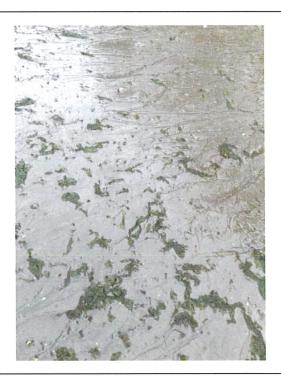
Photo 5 (Left): Northern area in project area (47.167, -122.827). Photo 6 (Right): Close-up of substrate (47.169, -122.825).

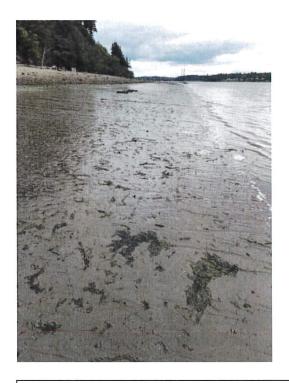
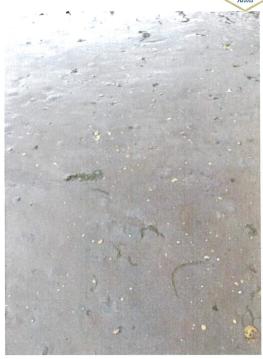
Photo 7 (Left): Southern end of project area (47.170, -122.825). Photo 8 (Right): Close-up of ground along southern end of project area (47.168, -122.826).

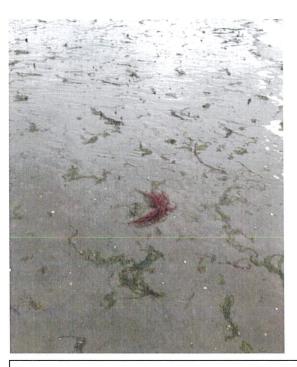
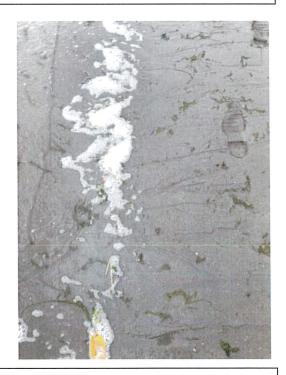
Photo 9 (Right): Substrate along the water line (47.168, -122.826). Photo 10 (Left): Close-up of substrate along the water line (47.169, -122.825).

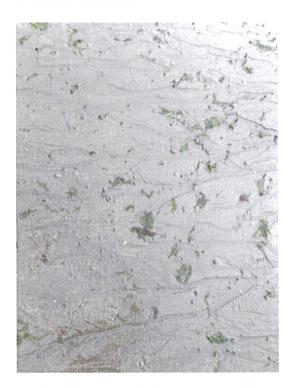
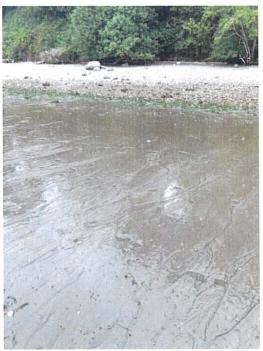
Photo 11 (Left): Close-up of substrate along southern boundary of project area (47.170, -122.825). Photo 12 (Right): Upper beach on southern boundary of project area (47.170, -122.825).

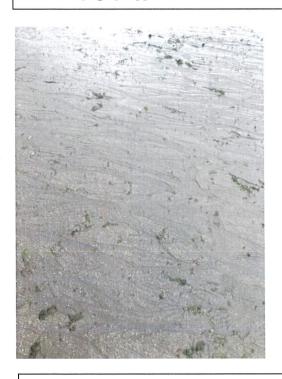
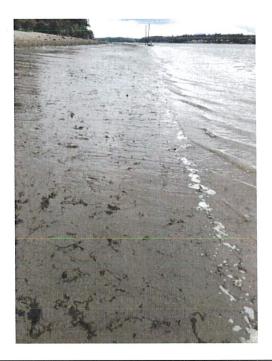
Photo 13 (Left): Close-up of substrate along southern border of project area (47.170, -122.825). Photo 14 (Right): Southern end of project area, facing north (47.170, -122.825)
