Critical Area Report and Mitigation Plan: NW Green Homes SFR (RUE)

Site Address: 13401 Marksman Street SW, Olympia, WA

Prepared By:
West Fork Environmental
2350 Mottman Road SW, Tumwater, WA 98512
(360) 753-0485

Report Date: March 15, 2023 (updated October 2023)

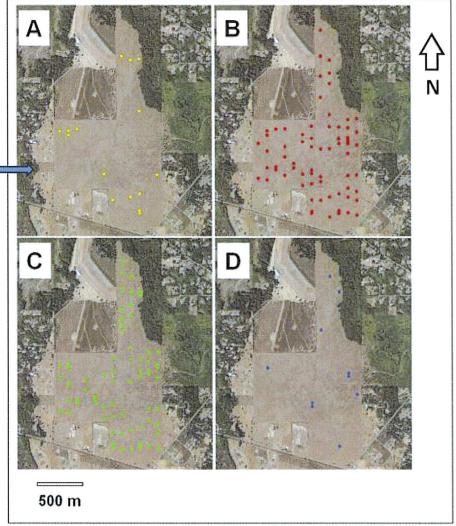
Figure 3. Spatial distributions of reindeer lichens at Mima Mounds, with presences at 106 sample points denoted by filled circles, absences not depicted. Key: A = Cladonia ciliata usnic chemotype, B = C. ciliata, C = C. portentosa, and D = C. rangiferina.

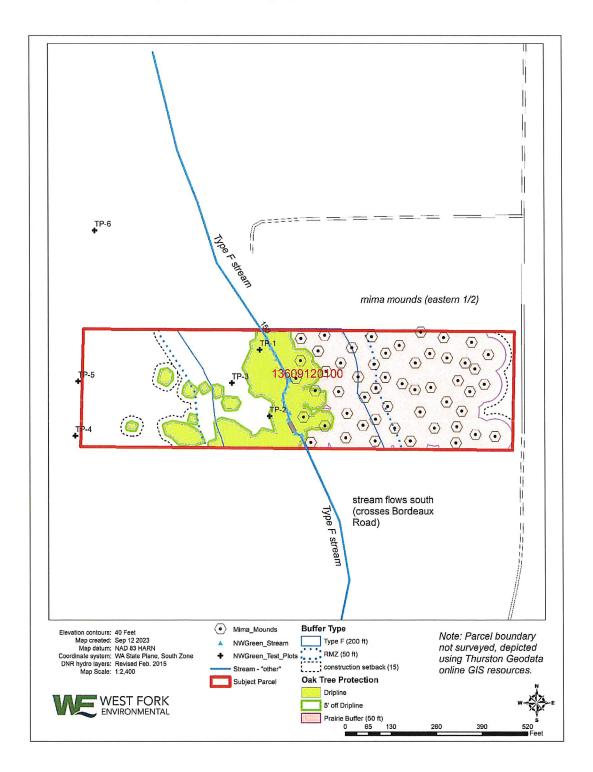
Figure 4. Test plot locations, stream edge GPS points, and Thurston County regulatory buffer plus 15-foot construction setback on the subject parcel. Mima mound prairie and oak woodland habitat delineated in spring 2022 and displayed below.

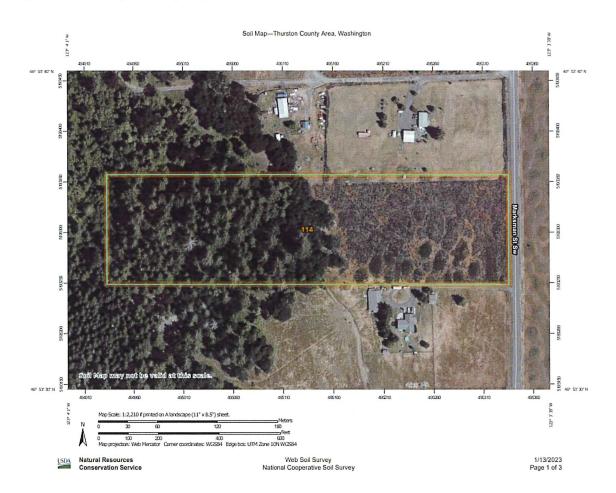
Figure 5. Soils map for subject parcel.

Map Unit Symbol	Map Unit Name	Acres in AOI	Percent of AOI
114	Spanaway-Nisqually complex, 2 to 10 percent slopes	10.9	100.0%
Totals for Area of Interest		10.9	100.0%

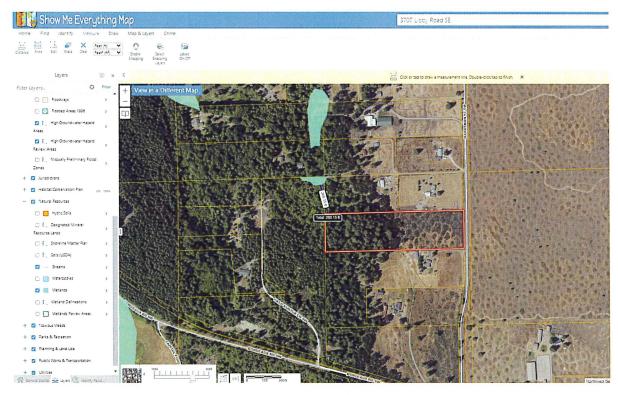
Figure 6. Thurston County Geodata Map of subject parcel showing potential wetland areas.

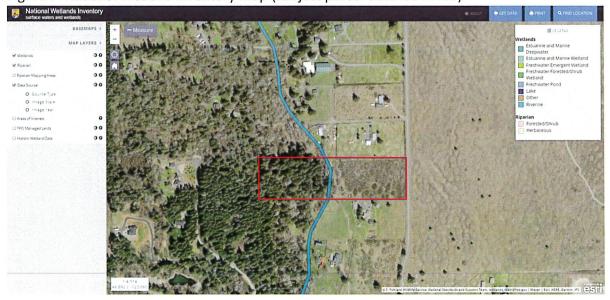
Figure 7. National Wetland Inventory Map (subject parcel outlined in red).

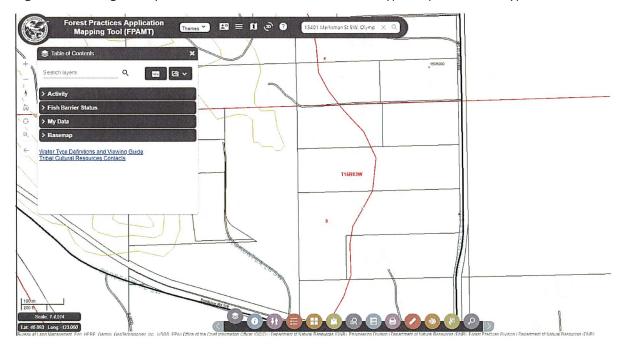
Figure 8. Washington Department of Natural Resources Stream Type Map – modeled Type F stream.

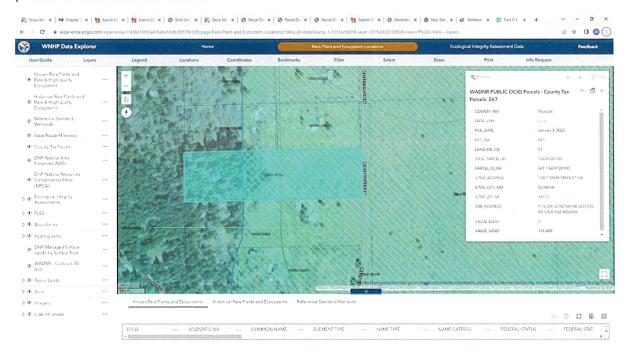
Figure 9. Washington Dept. of Natural Resources Natural Heritage – Rare Plant Location. Maritime reindeer lichen, White top aster, and Cup lichen are mapped over the property and are known to be present in Mima Mounds Reserve.

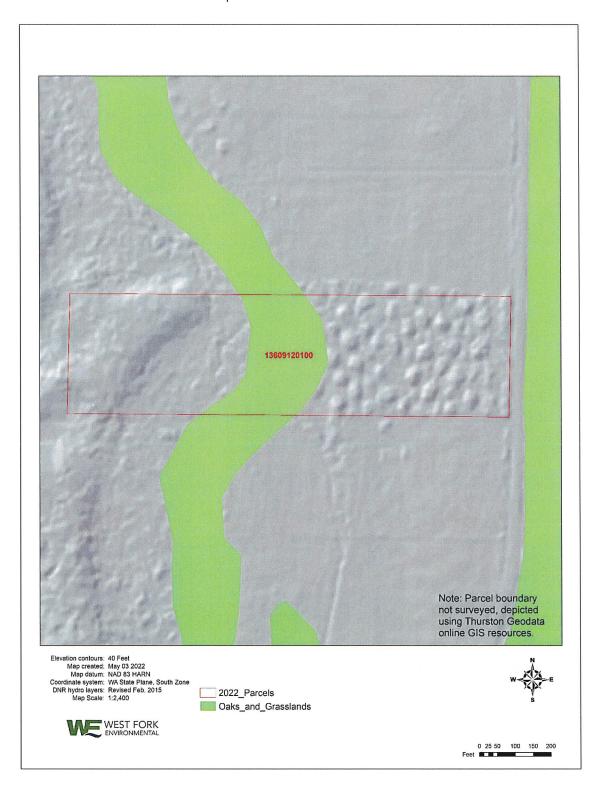
Figure 11. WDFW mapped oak habitat near the subject parcel and hillshade topography showing mima mound features in eastern half of the parcel.

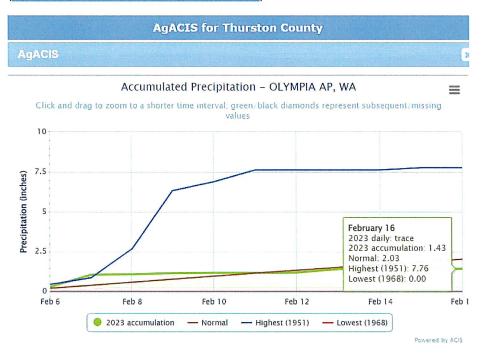
Figure 12. Rainfall Accumulation February 6, 2023, through February 16, 2023 (https://efotg.sc.egov.usda.gov/#/state/WA).

Rainfall totals in early 2023 were slightly lower than normal as recorded at the Olympia Regional Airport (Figure 12). A total of 1.43 inches accumulated in the 10 days before our survey (from February 6 to February 16) while an average of 2.03 inches is typically recorded. A standard WETS analysis of precipitation data showed that conditions were normal at the time of our survey.

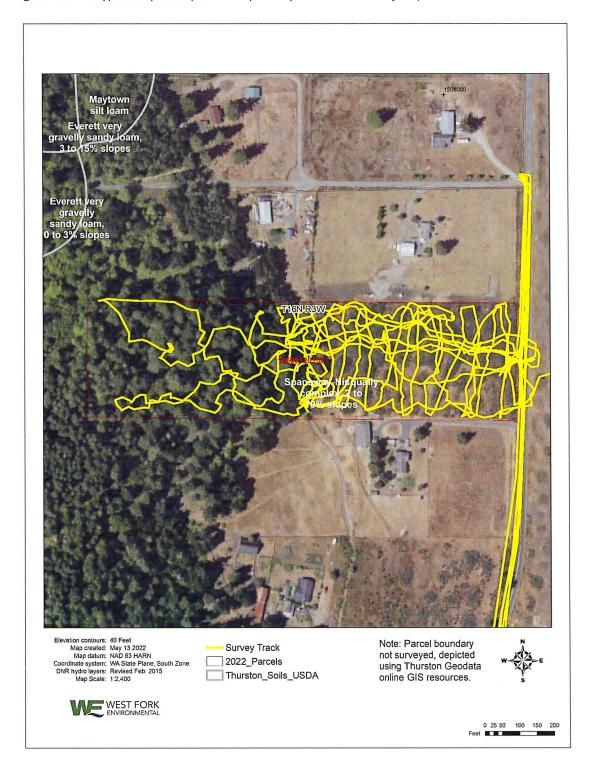
Figure 13. Soil type and prairie plant study survey transects on subject parcel.

According to Thurston County Critical Areas Ordinance (CAO 24.25), the parcel contains soil types associated with prairies. Transects were walked throughout the parcel and a list of plant species encountered during the survey was recorded as detailed in Thurston County's prairie review guidance (Figure 13). CAO listed target prairie plants were noted and a GPS waypoint was collected at each observation. The location of mima mounds was reviewed in the field and compared to LiDar imagery of the parcel. GPS waypoints were collected on top of mound features and mapped.

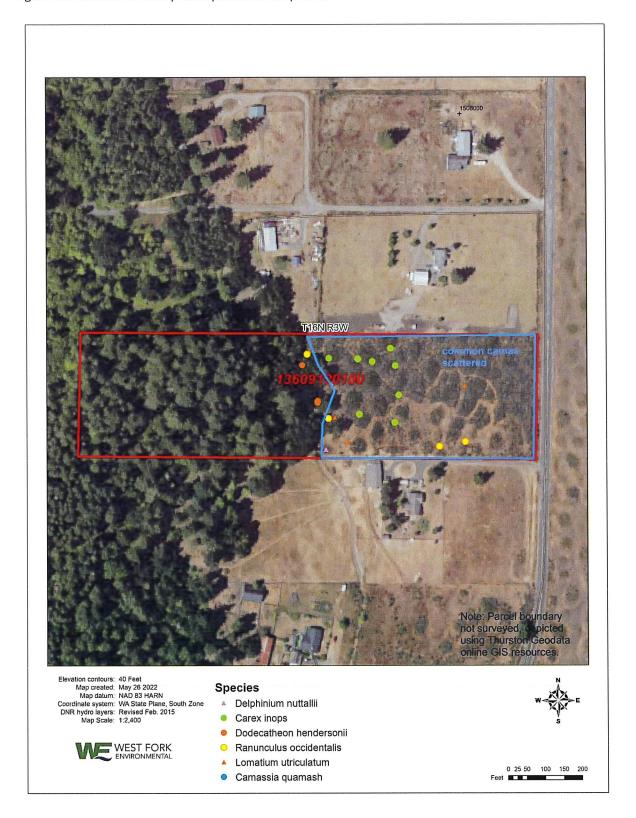
Figure 14. Location of CAO prairie plants on the parcel.

Six of the target prairie plant species identified in the Thurston County CAO were detected on the parcel (Figure 14). Common camas was scattered throughout the eastern portion of the parcel and was densest between the mima mounds. The other five CAO prairie plant species were observed in lower density in a few locations. The eastern portion of the property was mowed in 2022 but had a thick

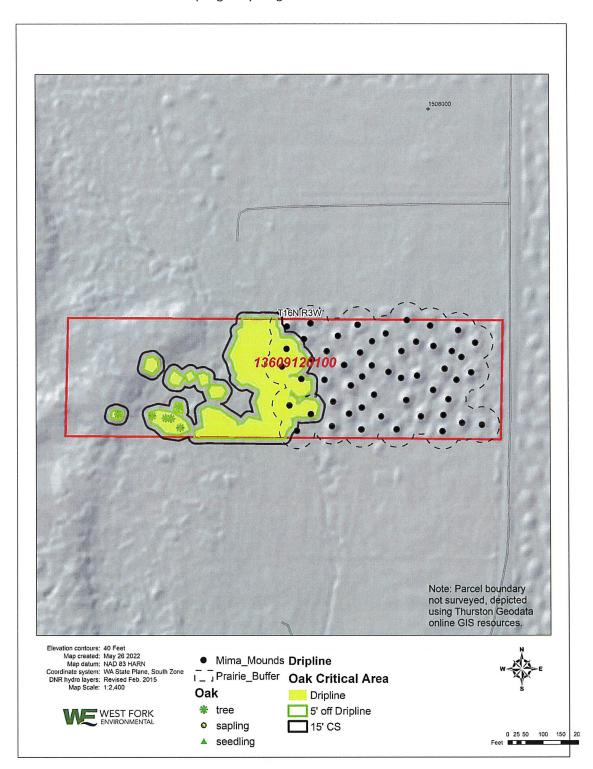
Figure 15. Location of mima mounds (plus 50-foot buffer) and Oregon oak protection zone on the parcel. Once a development plan is prepared for the western portion, a more careful evaluation of the forested habitat could reveal additional saplings or younger trees.

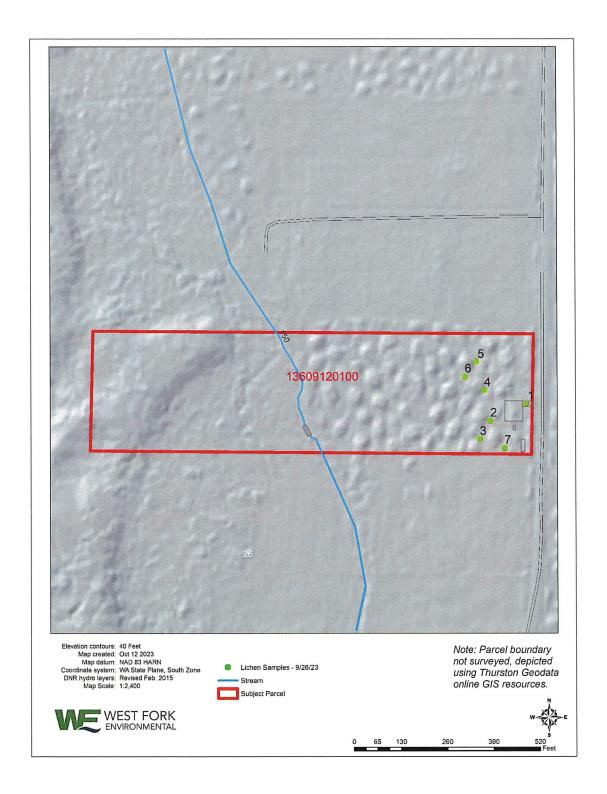
Figure 16. Lichen Samples collected September 2023 and identified by the Univ. of Washington Herbarium curator of lichen.

The WADNR Natural Heritage Program map showed that two rare lichen species were potentially on the property. The curator of lichen at the UW Herbarium provided identification of seven samples from the proposed development area. We did not sample the entire property because most of the area will be protected. Samples were collected from the eastern portion of the property to characterize the patches that we observed (Figure 16, Table 3). Dr. Glew found that samples 1, 4, 6 were cup lichen (*Cladonia ciliata*) and that samples 2 and 3 were maritime reindeer lichen (*Cladonia portentosa*).

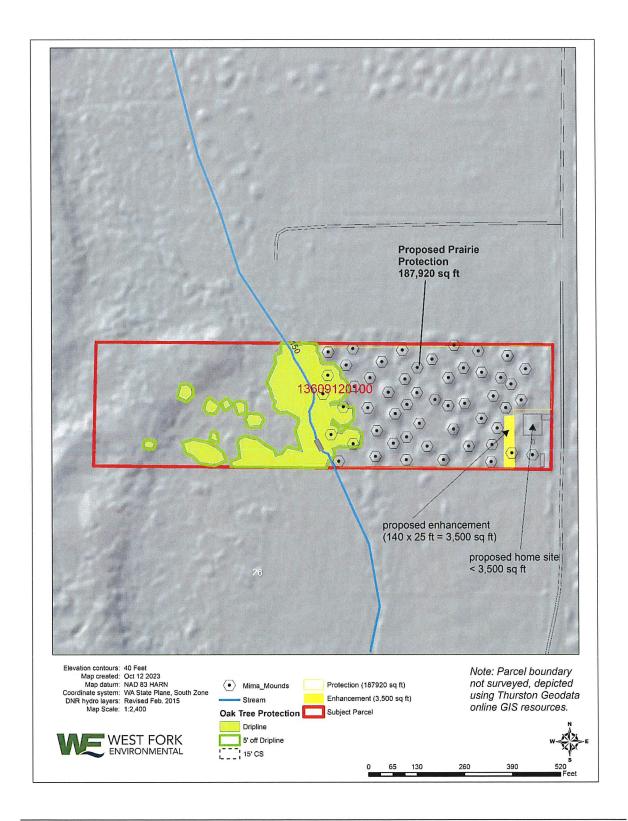
Figure 17. Proposed <3,500 sq ft home site and prairie enhancement area.

The landowner proposes a single-family home, onsite septic with a drain field, well and driveway in the southeastern corner of the parcel. Driveway access will be off Marksman Street SW. The site was selected because it is the most disturbed area on the property. The remainder of the property will be maintained in natural condition and a portion of the prairie habitat will be enhanced at a 1:1 ratio.

The applicant proposes a mitigation enhancement plan to improve degraded prairie habitat conditions in the eastern portion of the parcel immediately near the proposed home site. This action will meet the requirements of no-net-loss of habitat function. The extent of prairie and oak woodland habitats are limited in Thurston County and this particular site is directly across the street from the Mima Mounds Natural Area that provides habitat for endangered prairie species such as the Checkerspot butterfly. As such, it is an important patch of habitat to protect for the long-term conservation of prairie habitat in Thurston County.

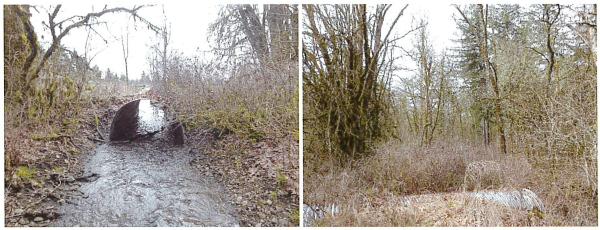
Seasonal stream - a corregated metal culvert is located in the stream channel (Figure 3). The stream is contained in banks and did not have associated wetland habitat. Barbed wire fences were observed at both north and south ends of property.

On the subject property, the stream flows south through an Oregon white oak woodland (*Quercus garryana*). The channel width is 6 to 8 feet and is contained within clearly defined banks. At the southern end of the parcel, there is a 6 foot diameter culvert in the channel that was placed by a previous owner (see site photos). No wetland habitat was observed along the stream on the subject parcel or visually on neighboring properties. There are barbed wire fences across the stream at both north and south property lines and we did not have access to adjacent properties.

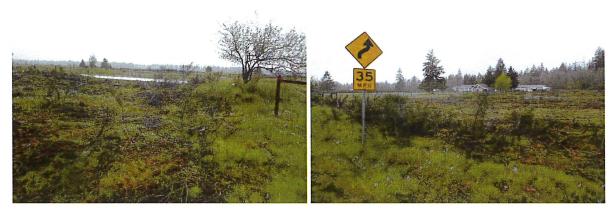
SE corner has the most disturbed area in the mima mound features.
