Update on Landslide Risks for Thurston County Washington

Presented to the Board of County Commissioners

June 25, 2014

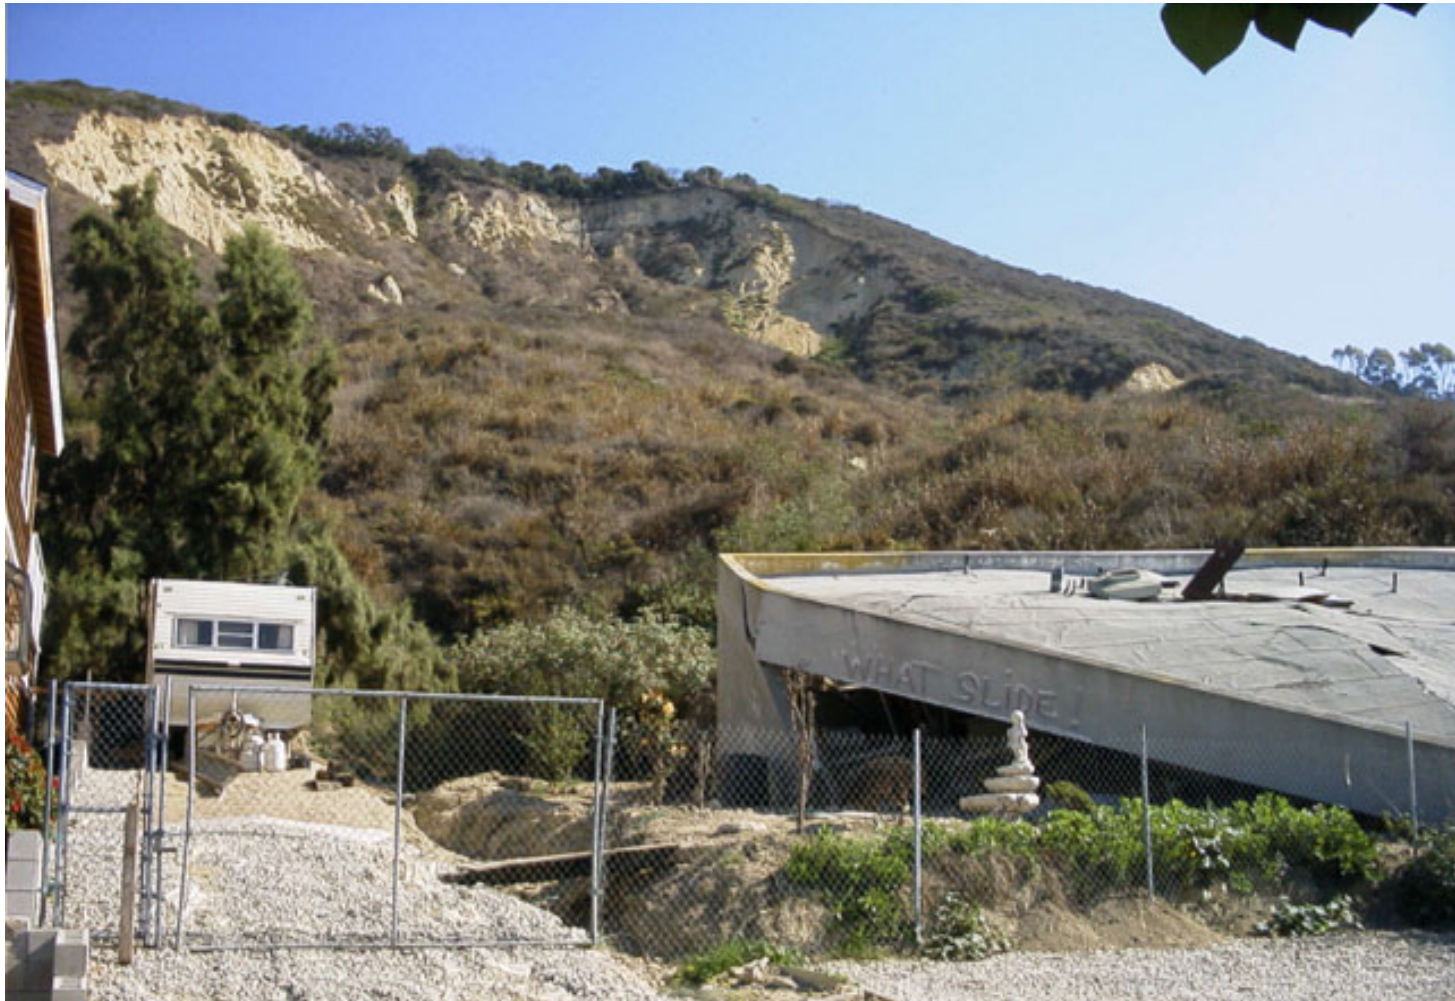
Type 1. Deep Seated Landslide- Failure plane is below the root line

This slide is approximately 500 thousand tons of material

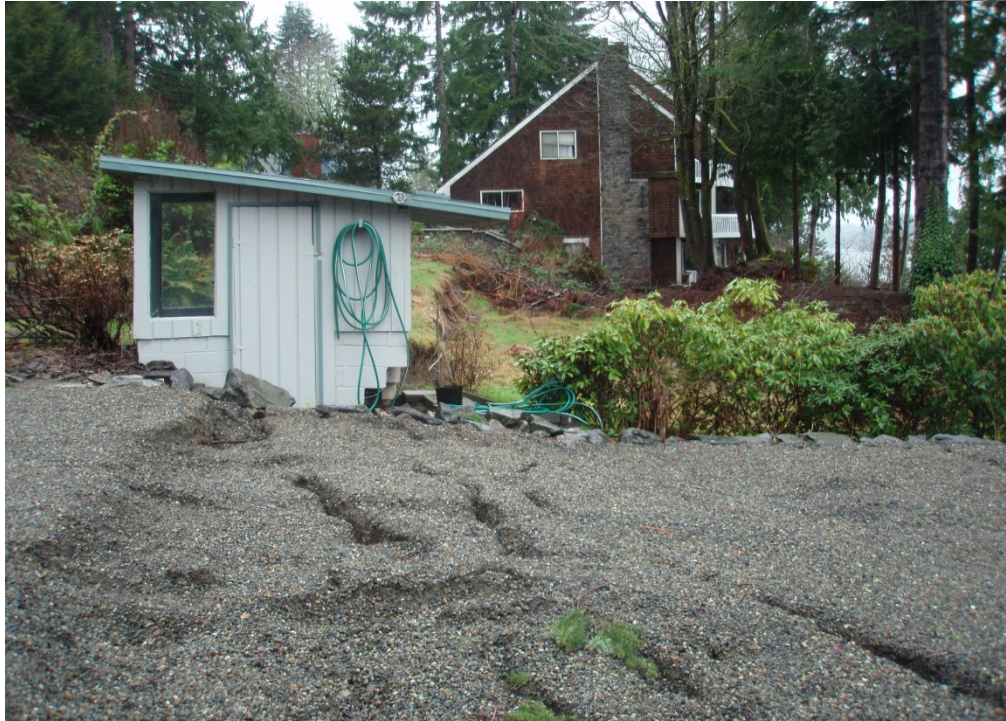
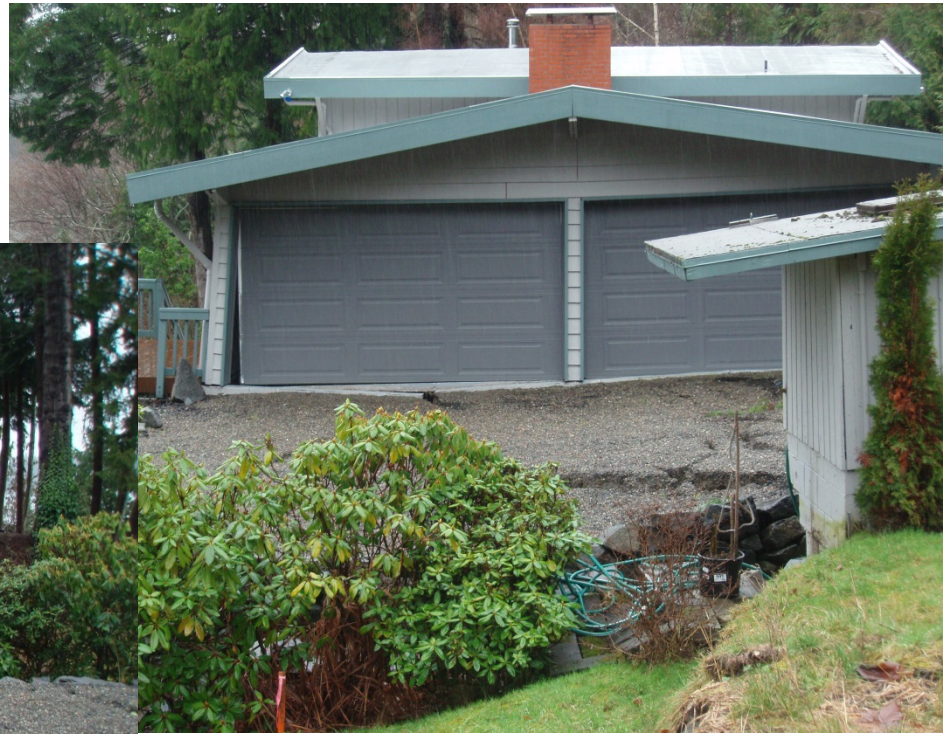
Type 1. Deep Seated Landslide Sunset Beach Landslide, Eld Inlet, Olympia, Washington

Third documented re-activation was in 2007

Three homes severely damaged

Typical geometry with arc-shaped scarps in “Step formation”

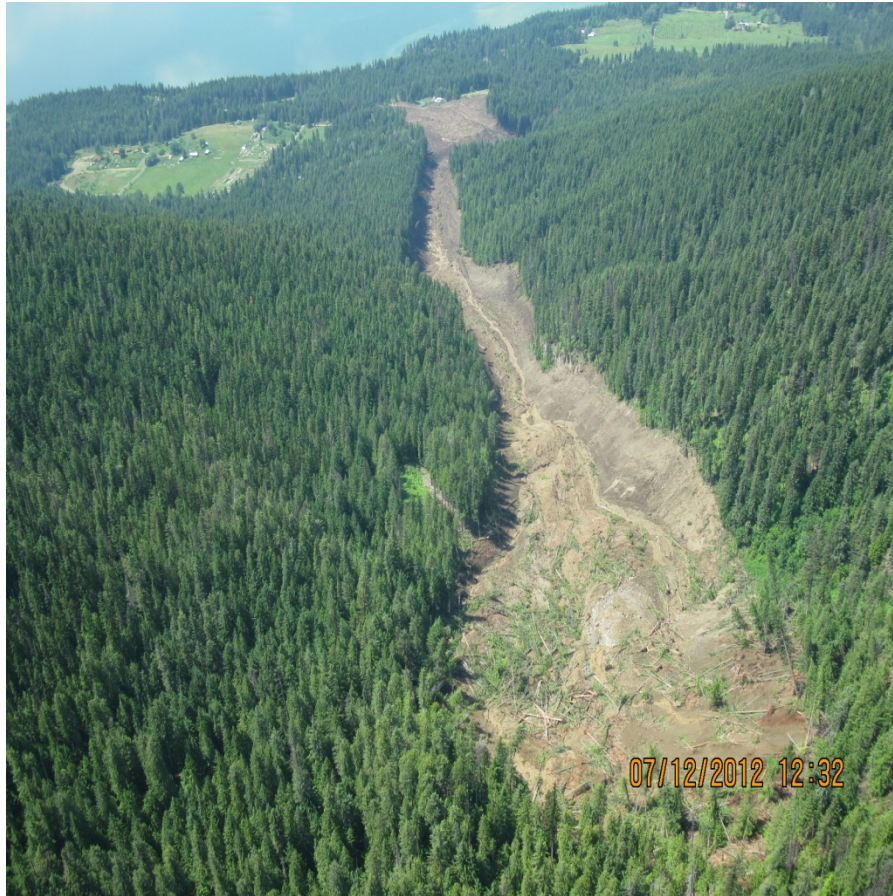
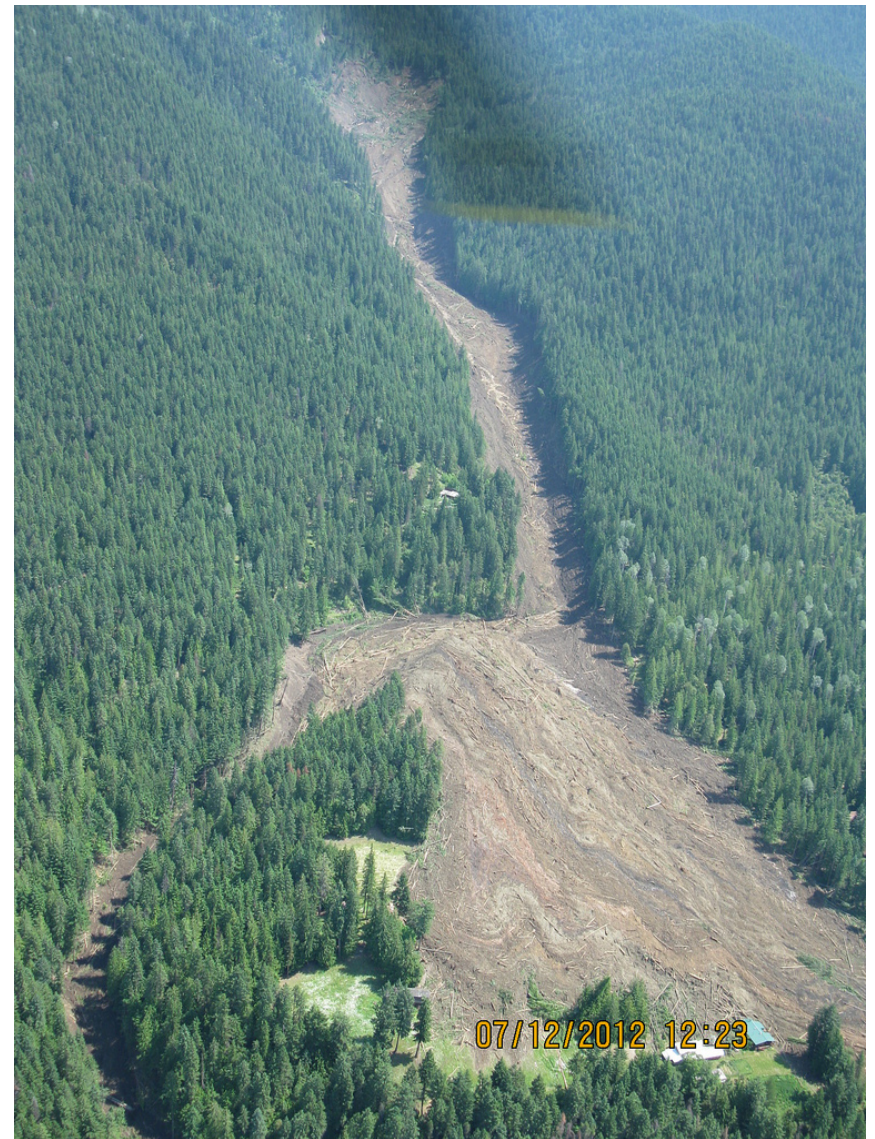
Type 2. Shallow Undifferentiated – Fast moving debris and water rich soils

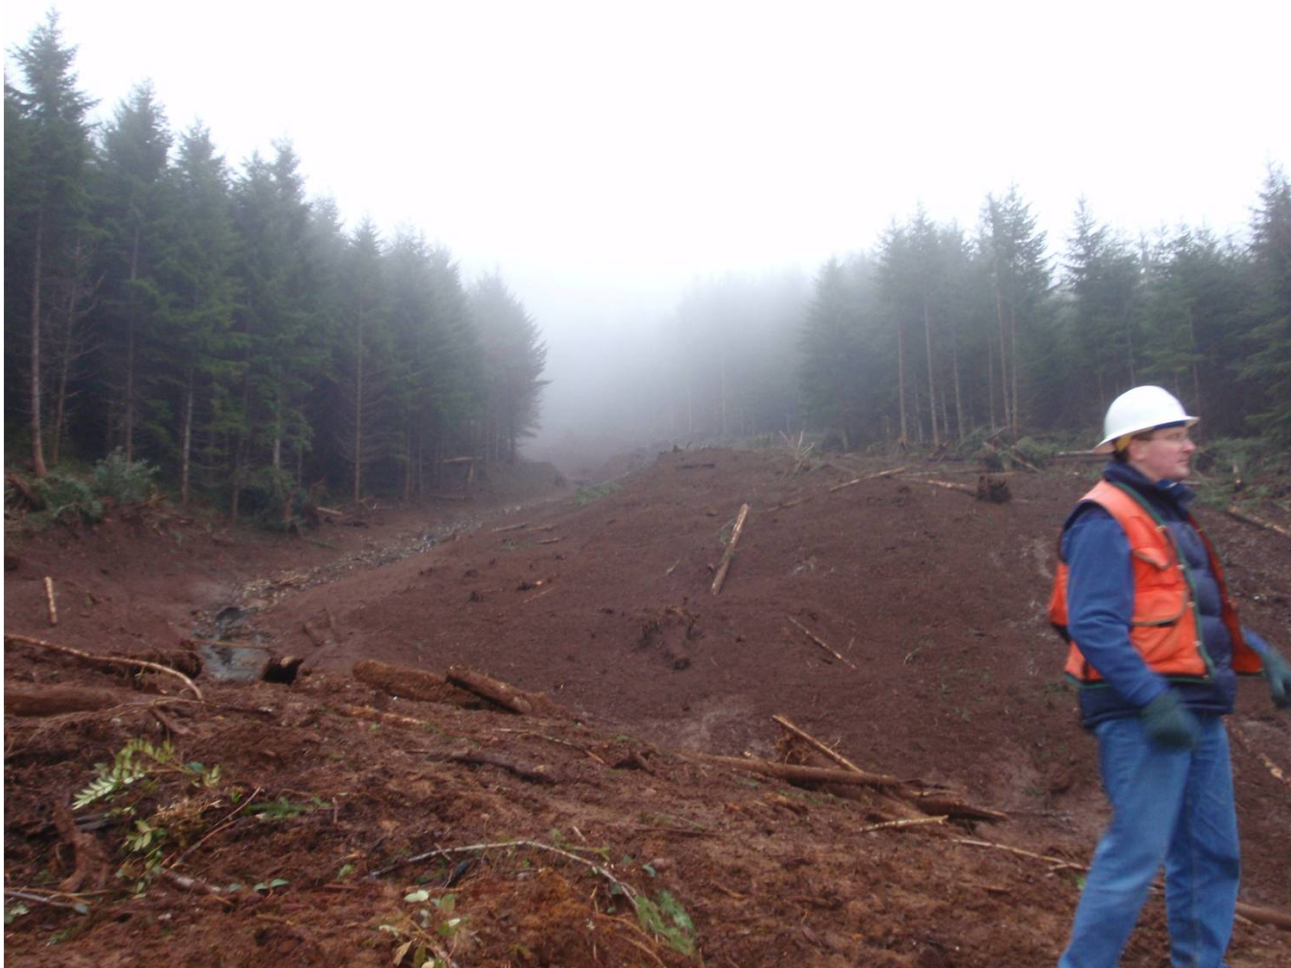
Type 2. Rock Candy Mountain Slide – Thurston County

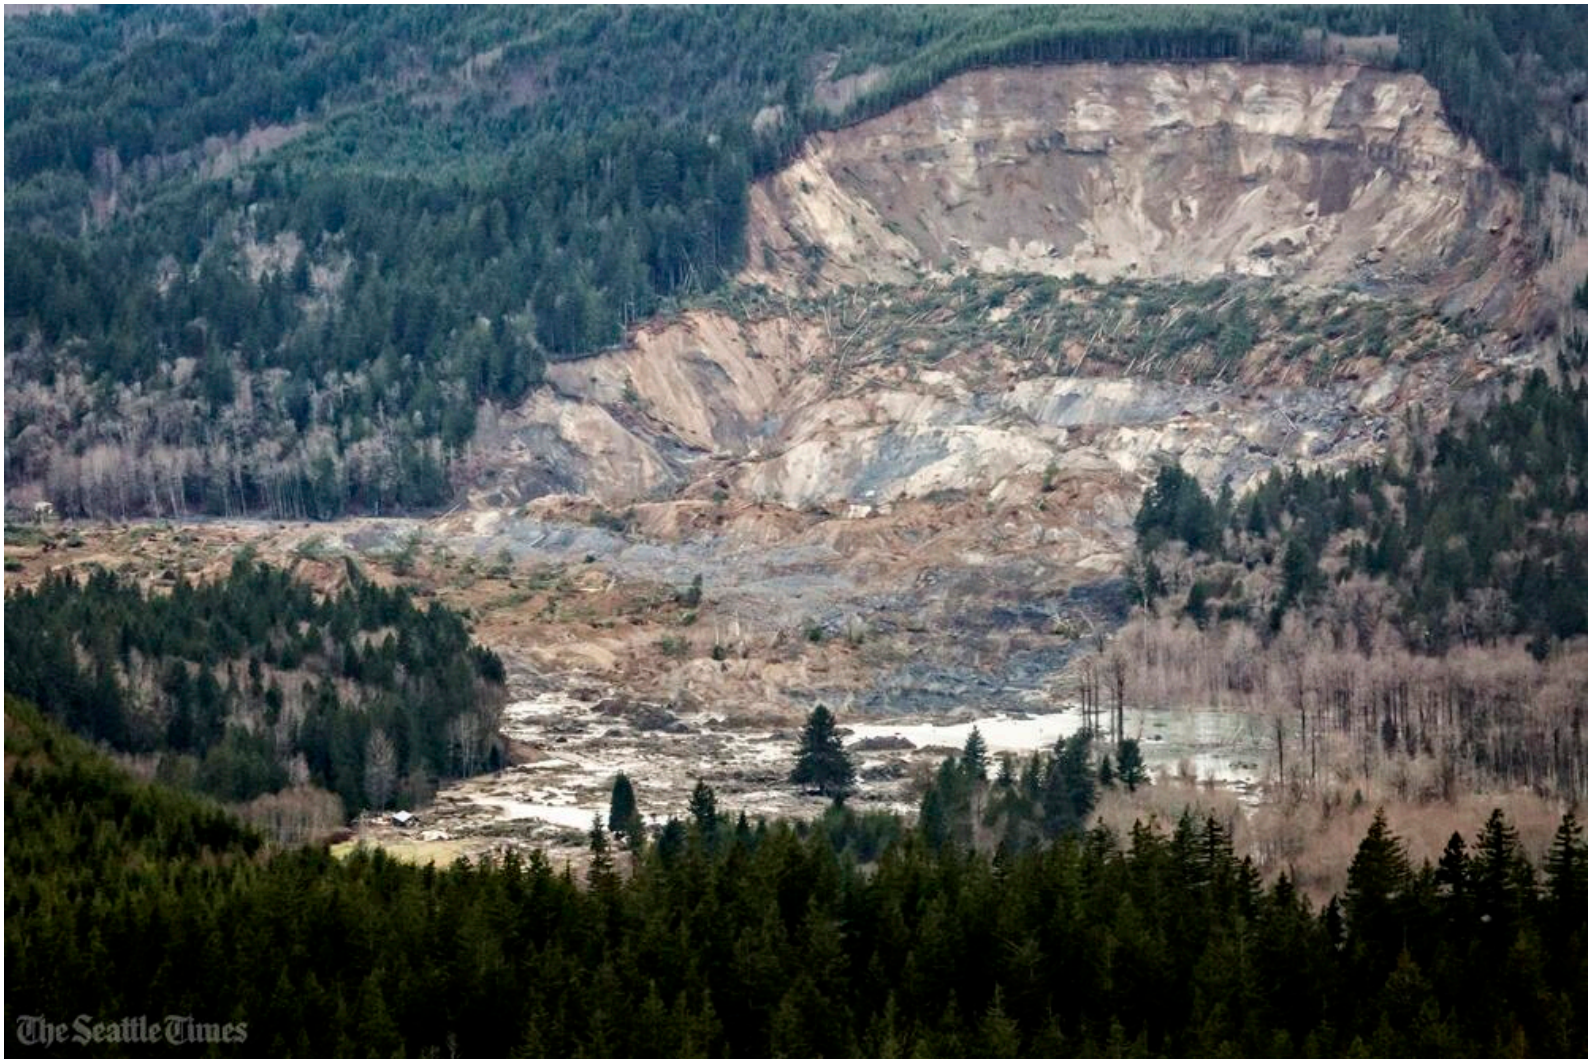
Type 3. [Oso Landslide](#) – Hybrid Deep Seated with massive blocks of soil and trees – very fast moving killed 44 people also impounded the Stillaguamish River for weeks

The March 22nd, 2014 Oso, Washington Slide was a *type 3 landslide*

- They are responsible for most damage and fatalities
- Fast moving and can be HUGE
- They are not common in South Puget Sound
- They occur where glacial geology , topography and rainfall have the right mix to start the unstable ground moving

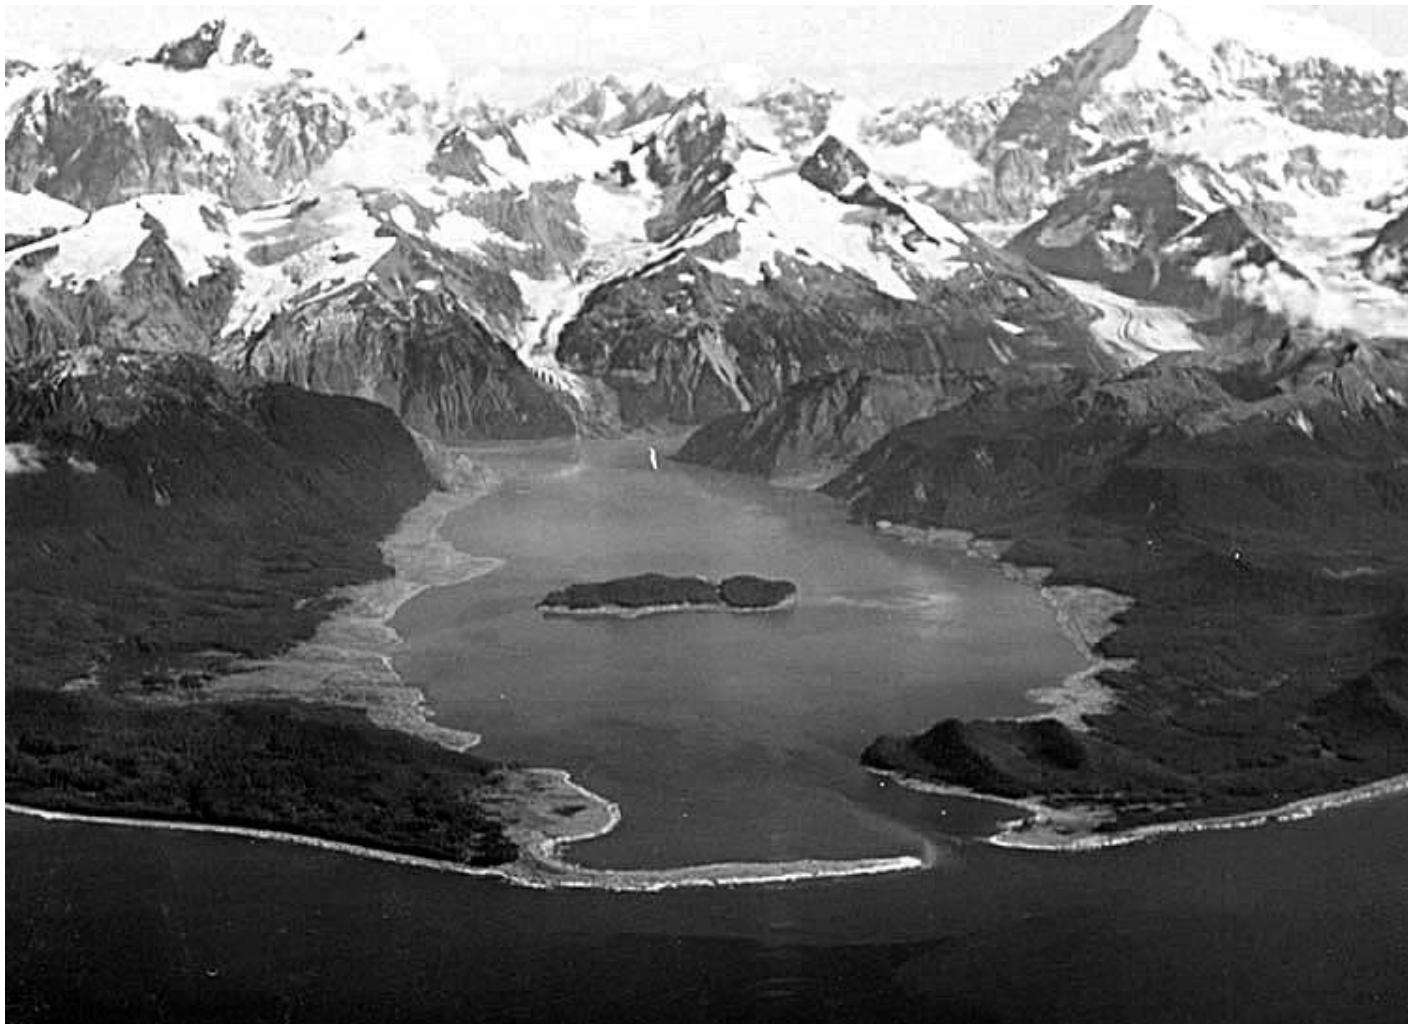
**Type 4. Seiche generated by a landslide impacting
Lituya Bay- Alaska (1950's)**

Wave Height 300 meters !!

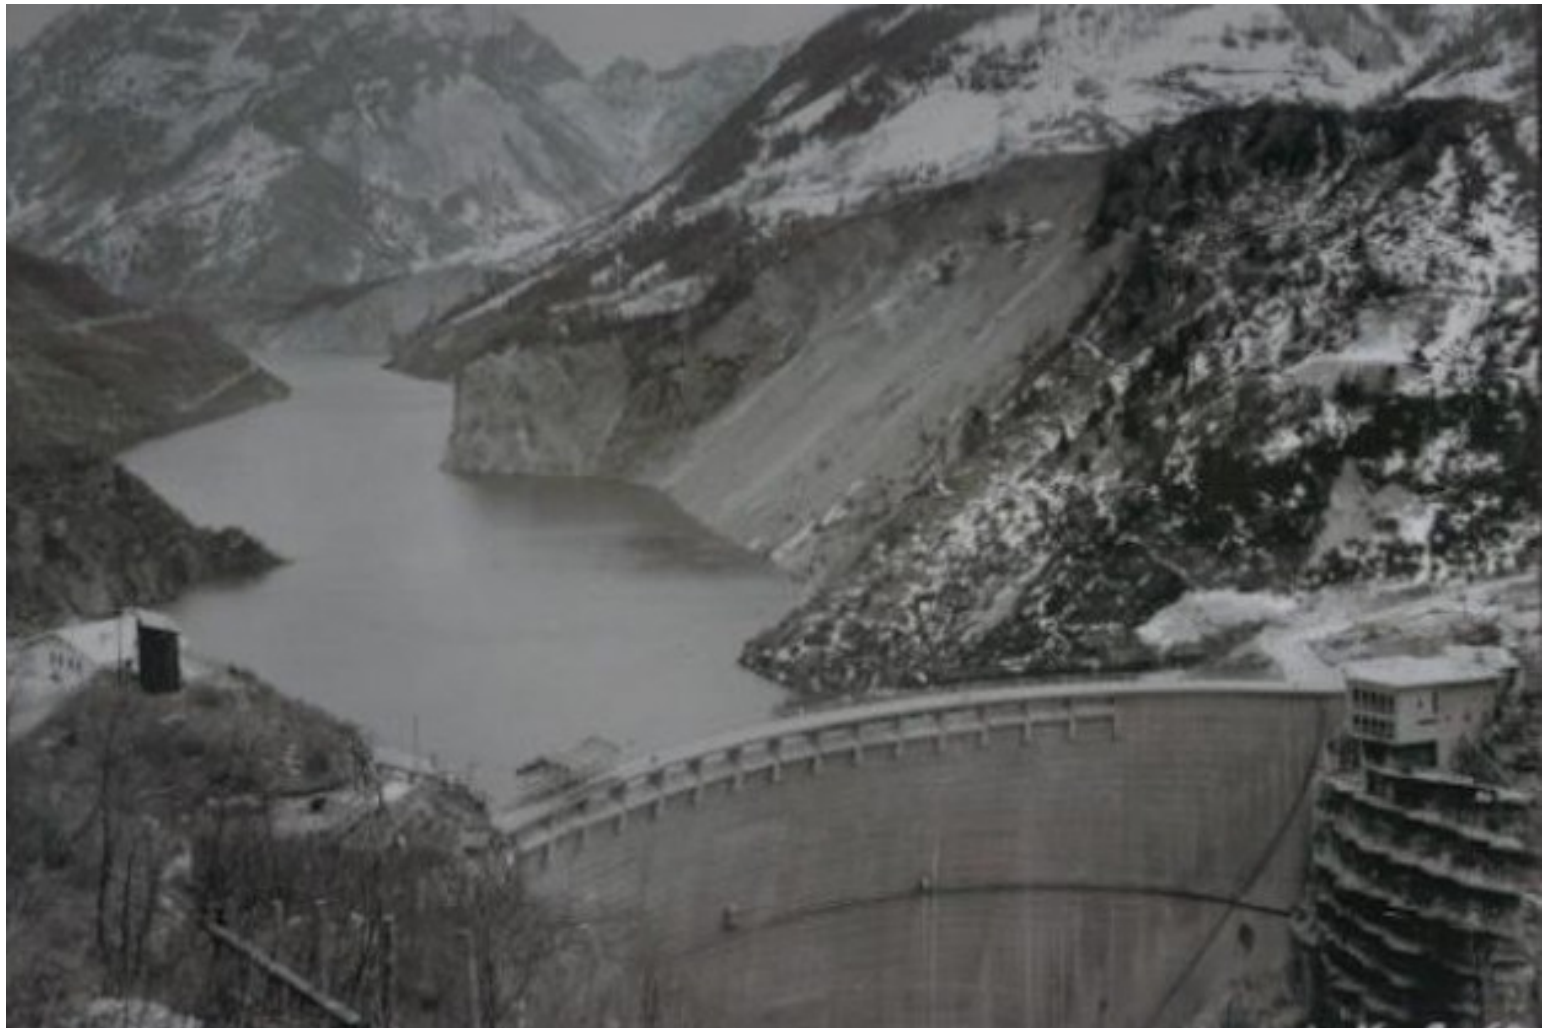
Type 4. Seiche Generated by Large Landslide impacting Lake with a 400 meter high dam (Italy)

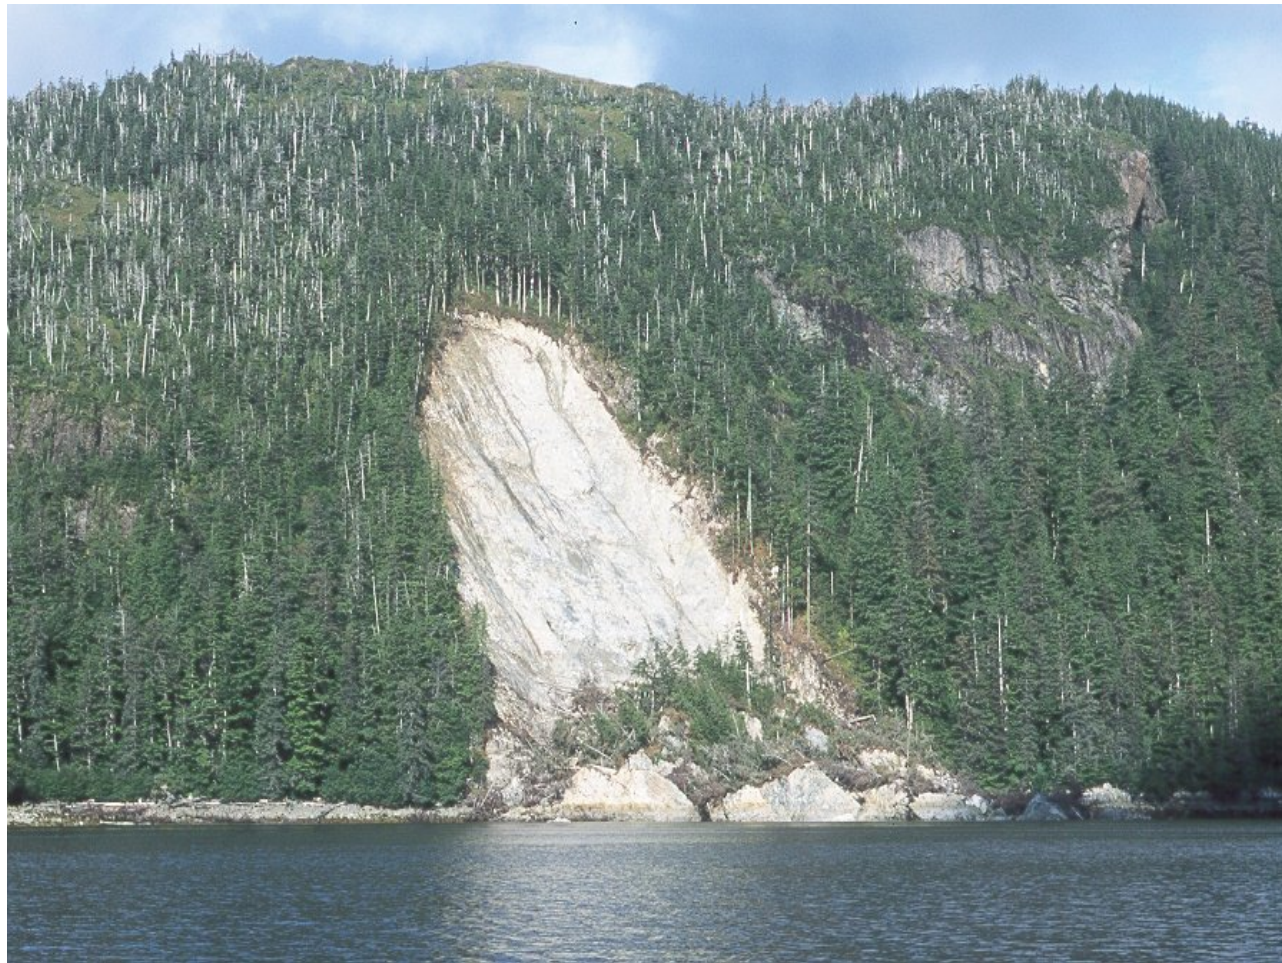
Type 4. Shallow debris and rockfall into a water body

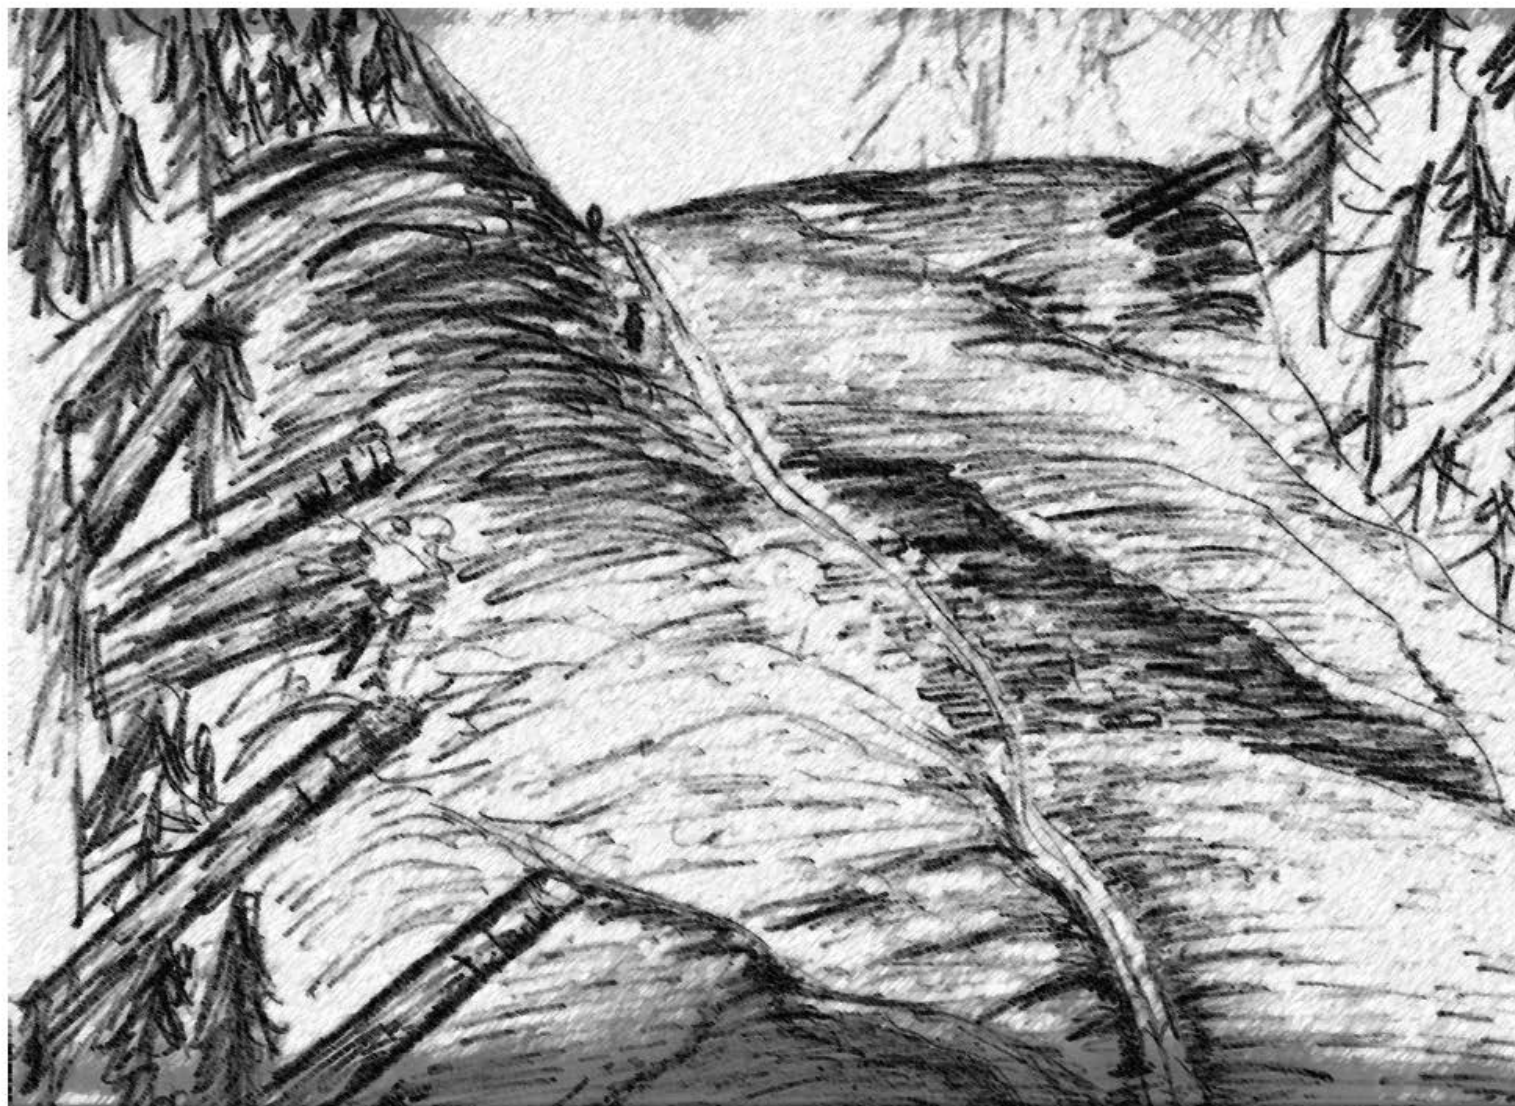
JANUARY 9, 2009
THE KENNEDY CREEK SLIDE BY N. ROMERO
