# Deschutes River Watershed Community Workshop

Thurston County Resource Stewardship

June 30, 2016

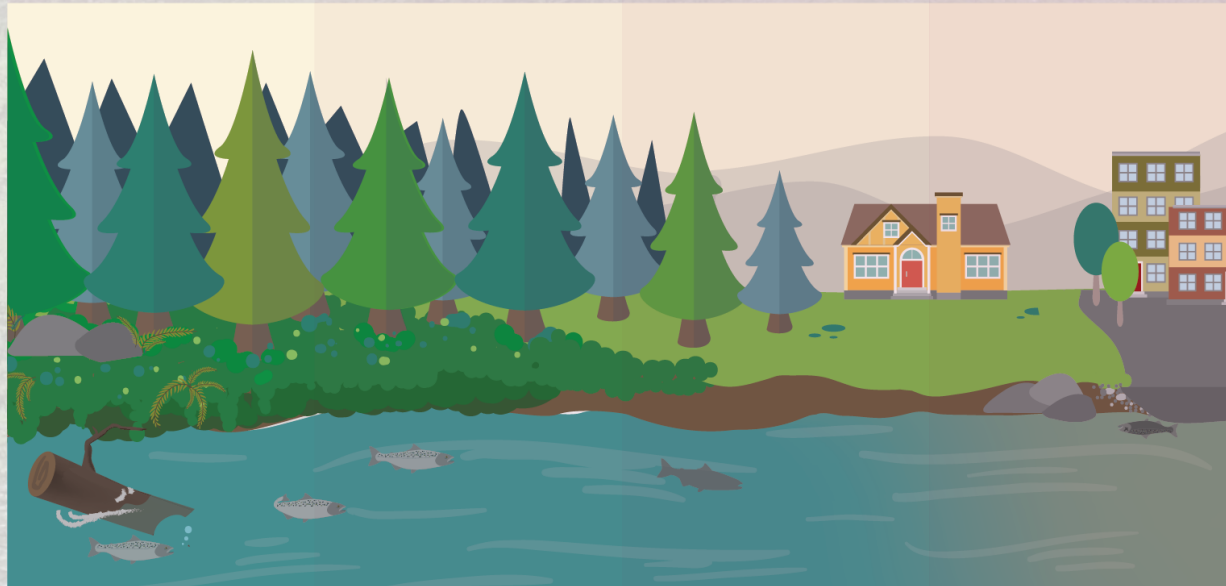
# Impervious Surface and Forest Cover

## Intact

Impervious Surface: <2%  
Forest Cover: >80%

- Water is cool and clean
- Stream banks and bottom typically stable
- Many fish species (less tolerant coho salmon more prevalent than cutthroat)
- Many insect taxa

## Sensitive

Impervious Surface: 2-10%  
Forest Cover: 65-80%

- Water may be warmer and slightly polluted
- Erosion may be evident
- Many pollution tolerant fish
- Many insect taxa

## Impacted

Impervious Surface: 10-25%  
Forest Cover: 45-65%

- Water warmer
- Erosion usually obvious
- Fewer fish species (shift to more tolerant cutthroat salmon)
- Mostly tolerant insects

## Degraded

Impervious Surface: >25%  
Forest Cover: 45-65%

- Warm water and pollution usually evident
- Unstable habitat
- Only tolerant fish species

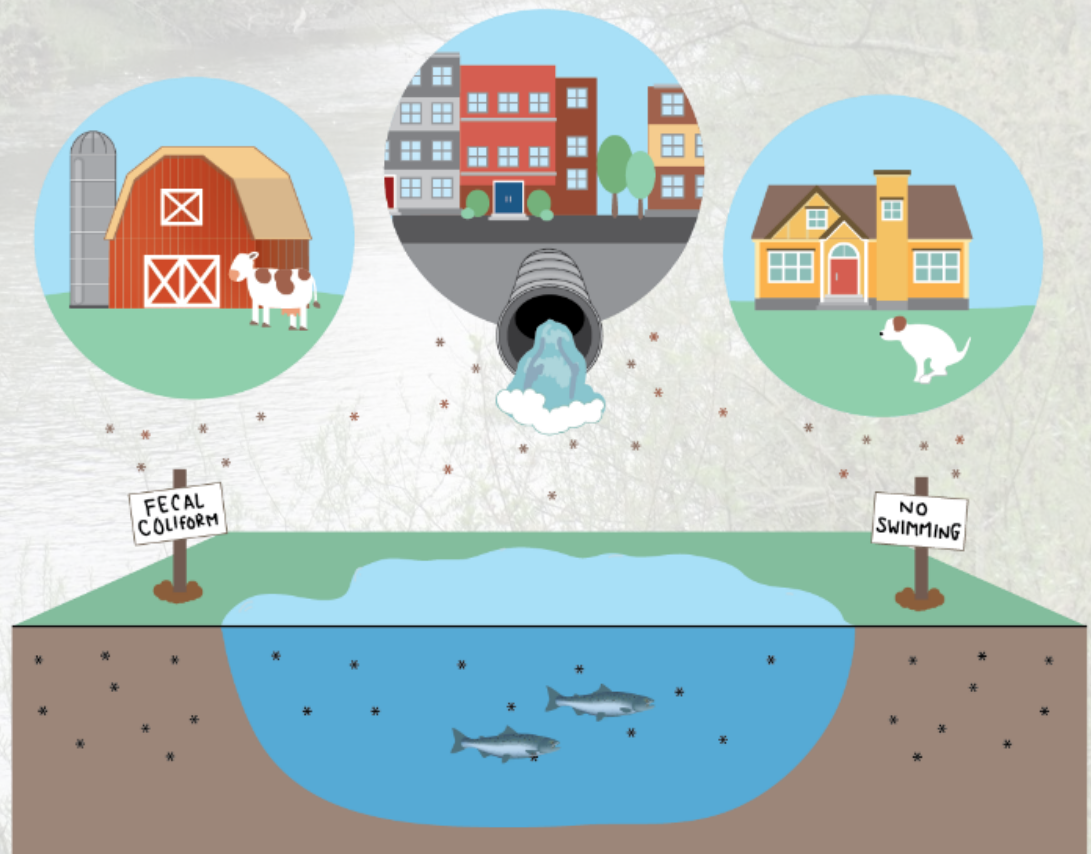
## Potential sources of fecal coliform include:

- Farm animal wastes
- Stormwater runoff
- Improperly connected sewers
- Failing septic systems
- Pet wastes

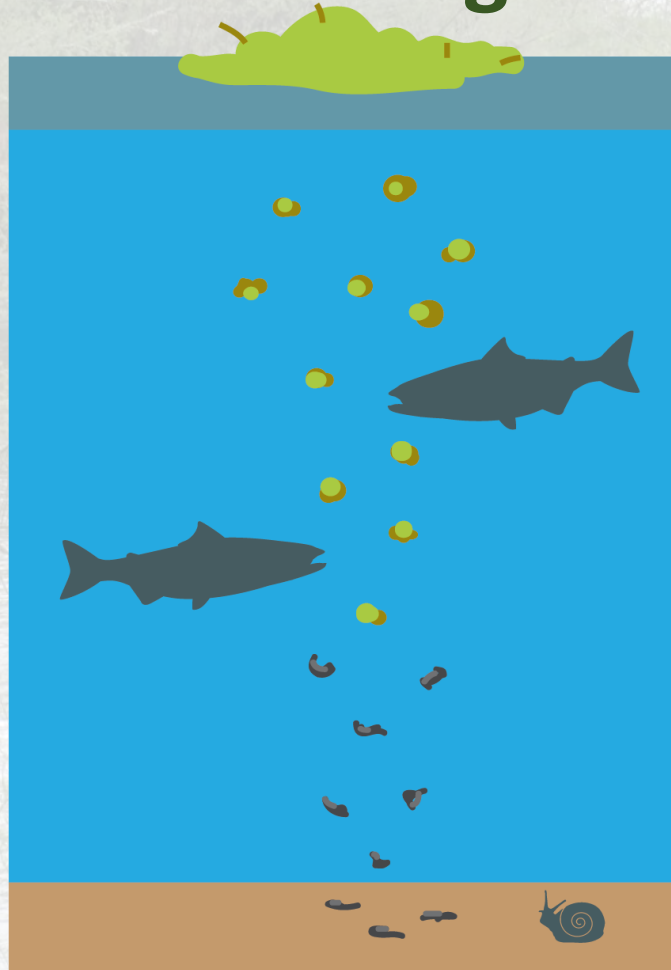
Nutrients from runoff and shallow groundwater fuel algae blooms in lakes.

Algae cells die and decompose.

Decomposition lowers dissolved oxygen concentrations in bottom waters.

Low dissolved oxygen stresses fish and other aquatic organisms.

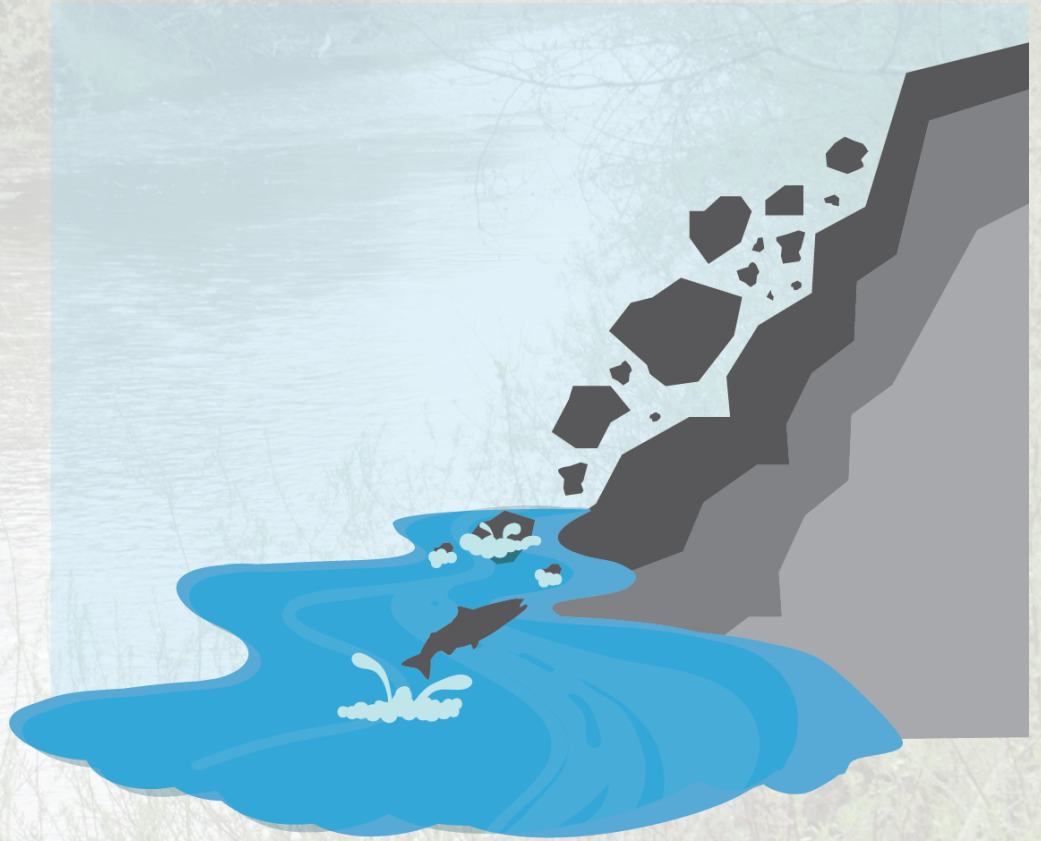
**Risk of landslides increases with removal of vegetation and road building**

**Erosion adds fine sediments to stream, degrading salmon spawning habitat**

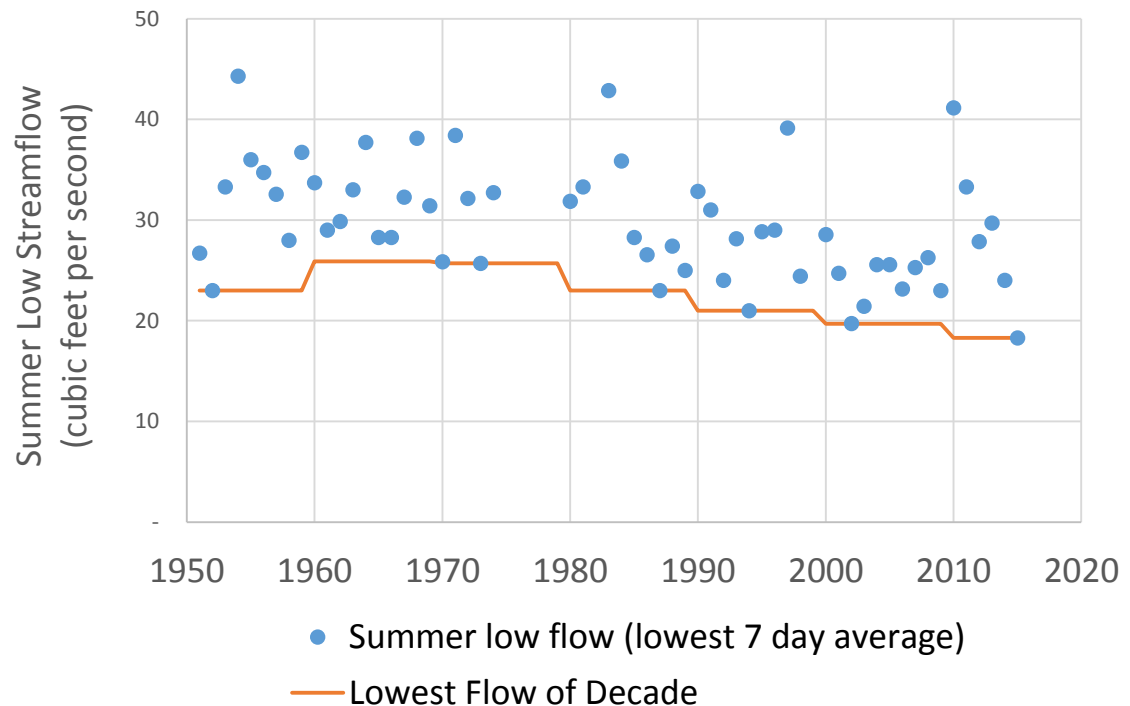
Rainier Gage Summer Low Flow  
(lowest 7 day average)

- Low summer stream flows in Deschutes River and effect on Coho salmon

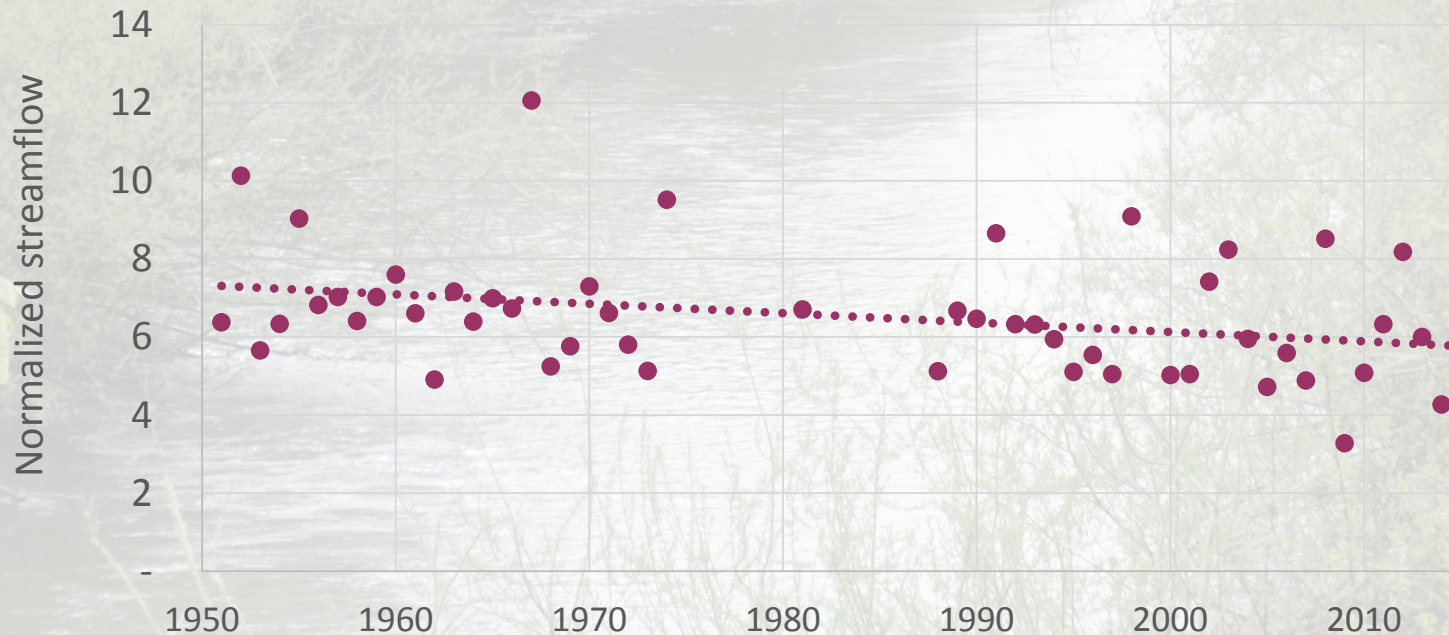
**Normalized Summer Streamflow**  
Summer streamflow (July to September) divided by  
Summer Precipitation (May to September)  
Deschutes River – Rainier Gage

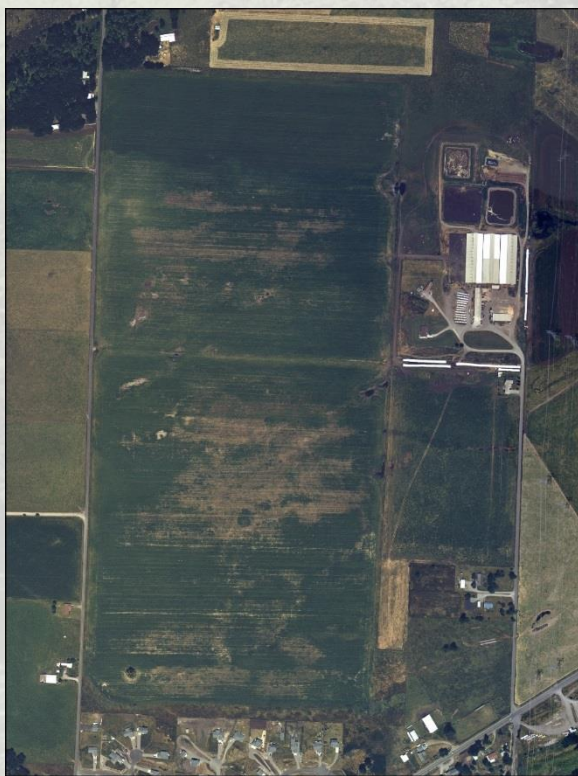
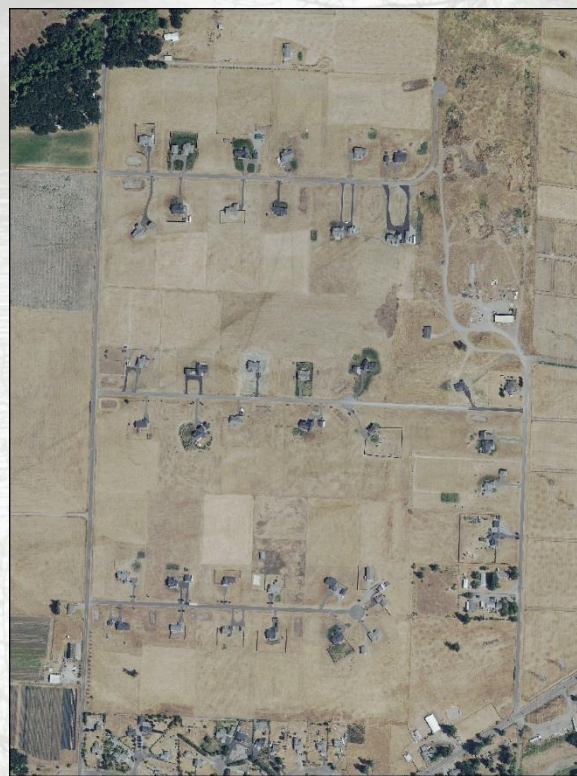
# Loss of Farmland – 2000 & 2015

- Over 700 acres lost between 2000 and 2011
