CHAPTER 4 - PROBLEM IDENTIFICATION AND ANALYSIS

4.1 OVERVIEW OF PROBLEMS

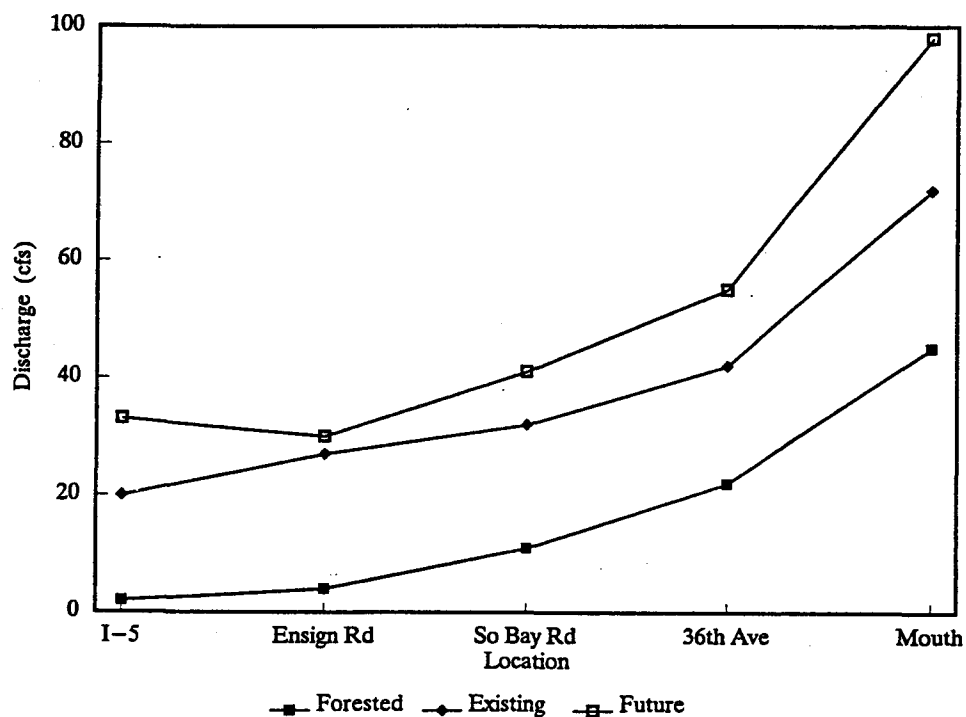
Figure 4-3 Impact of future development on Woodard Creek 2-year peak flows

Recent studies indicate that the smaller, more frequent events have a greater influence on channel morphology and stream habitat than large infrequent events such as the 100-year flows (Powers, Washington Department of Fisheries 1991). Figures 4-3 and 4-4 show the predicted increases in future flows at several locations along the creek.

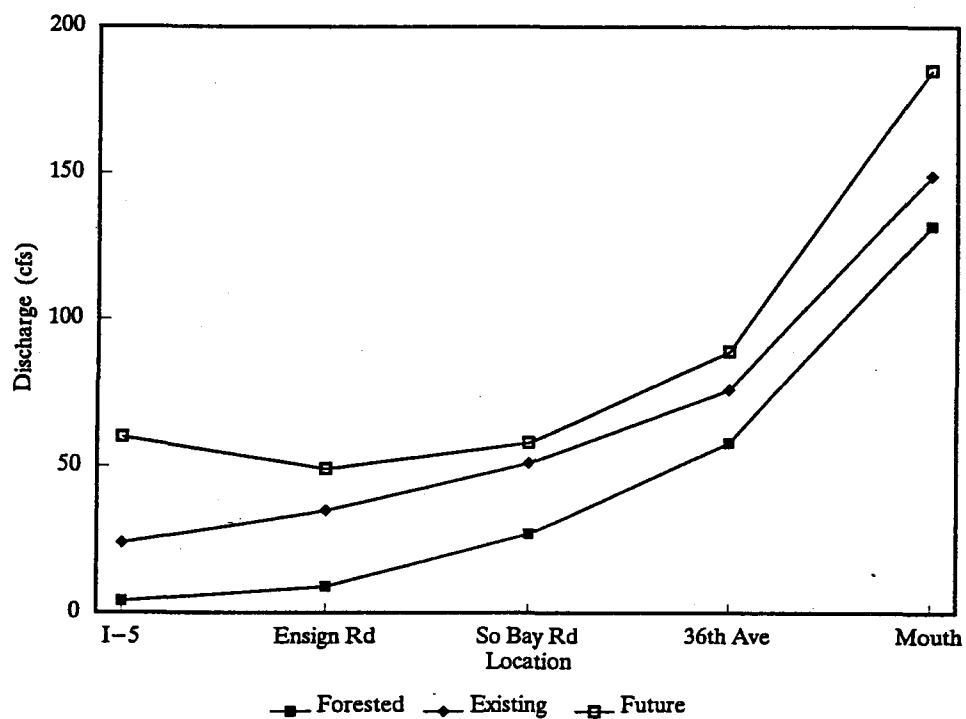
Figure 4-4 Impact of future development on Woodard Creek 100-year peak flows
