SHANNON & WILSON, INC.

This letter report presents our findings, conclusions, and engineering recommendations regarding a landslide that has affected private properties and the public roadway in the 4800 to 5000 blocks of Sunrise Beach Road NW in Thurston County, Washington, as shown on the Vicinity Map (Figure 1) and Site Plan (Figure 2). The purpose of this work is to provide an evaluation of the causes of landsliding, provide recommendations to increase the stability of the hillside, and formulate additional recommendations for monitoring of future remedial measures and instrumentation of the hillside

The landslide is located along Sunrise Beach Road NW, on the west side of Eld Inlet, as shown on Figure 1. It encompasses an area about 1,700 feet wide from north to south, and about 350 feet long from east to west, as indicated on the Site Plan, Figure 2. The paved road, about 18 feet wide, is located on a bench at about elevation 45 to 54 feet. The road is highest on the two ends and has two locally low spots in the vicinity of the Lawrence and Christensen properties. Approximately 20 residences are located between the roadway and Eld Inlet in the area that experienced slope mo

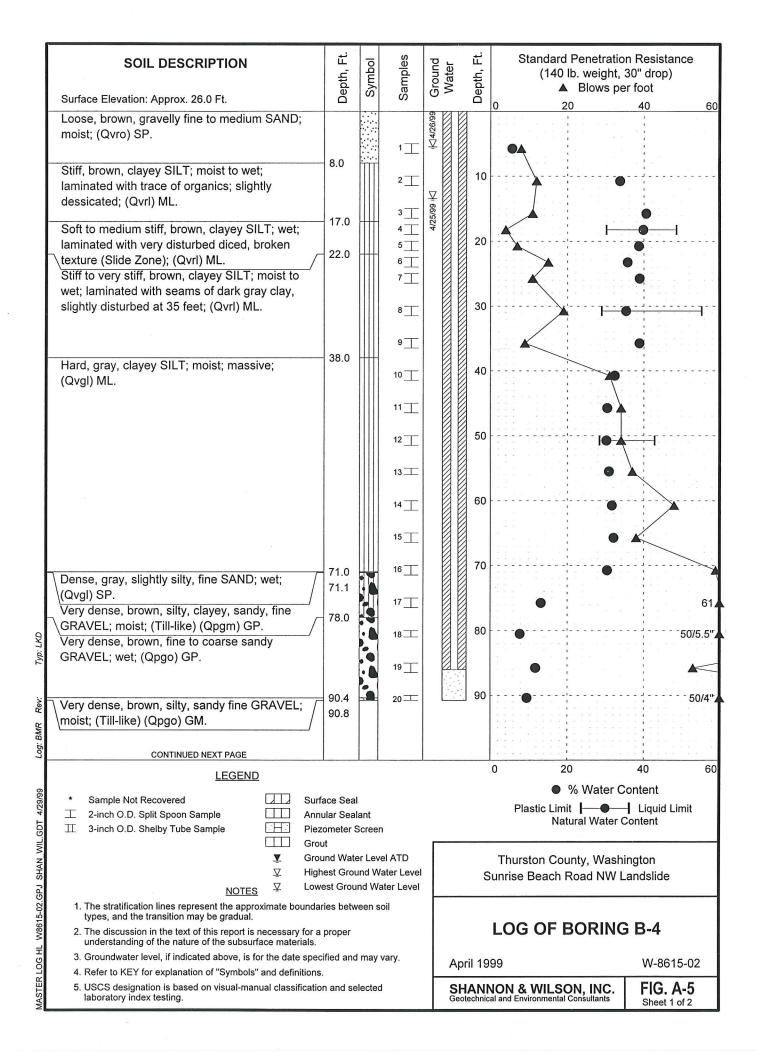
Г				T T			
1	SOIL DESCRIPTION	芷	0	<u>8</u>	면 h	芷	Standard Penetration Resistance
١		Depth, I	Symbol	Samples	Ground Water	Depth,	(140 lb. weight, 30" drop) ▲ Blows per foot
١	Surface Elevation: Approx. 26.0 Ft.	De	(Q)	S _S	ტ >	De	0 20 40 60
I	BOTTOM OF BORING						20 40 00
1	COMPLETED 4/21/99						1
1	Notes:						
١	(4) Indianate region installed to 96 feet					110	
١	 Inclinometer casing installed to 86 feet deep. 						
ı	(2) Vibrating wire pressure transducer at 93						
ı	feet.						
ı						120	
١							
١							
١						130	
١				-		130	1
ı							
١							
ı						140	
١							
ı							
١						450	
1						150	
ı							
١						160	
ļ							
1							
						170	1
							1 1 1 1 1 1 1 1 1 1 1 1 1 1 1 1 1 1 1
١							
						180	
1							
l yp							
I							
						190	
۲							
DIMI.							
703							
ı	LEGEND						0 20 40 60
88/8	* Sample Not Recovered Surfa	ace Sea	ı				Water Content
4/2		ular Sea	lant				Plastic Limit — Liquid Limit Natural Water Content

3	strength to statement in the statement of the statement o	ometer S	Scree	en			Mataral Water Comment
\$	☐☐☐ Grot ▼ Grot	ut und Wate	er I e	vel ATD			Thurston County, Washington
HAN				Vater Level		S	unrise Beach Road NW Landslide
2	NOTES \(\frac{\triangle}{\triangle}\) Lower	est Grou	nd W	/ater Level			diffice Beach Road 1444 Earlacing
-02.6	The stratification lines represent the approximate boundar	ries betw	een:	soil

80.13	types, and the transition may be gradual. 2. The discussion in the text of this report is necessary for a	nroner					LOG OF BORING B-4
<u> </u>	understanding of the nature of the subsurface materials.						
5	3. Groundwater level, if indicated above, is for the date spec		d may	vary.	Ap	ril 19	99 W-8615-02
T L	 Refer to KEY for explanation of "Symbols" and definitions. USCS designation is based on visual-manual classification 		electo	ad			
ç	5. USCS designation is based on visual-manual classification laboratory index testing.	ii ailū še	eiecte	u	Geo	TANN technic	NON & WILSON, INC. FIG. A-5 al and Environmental Consultants

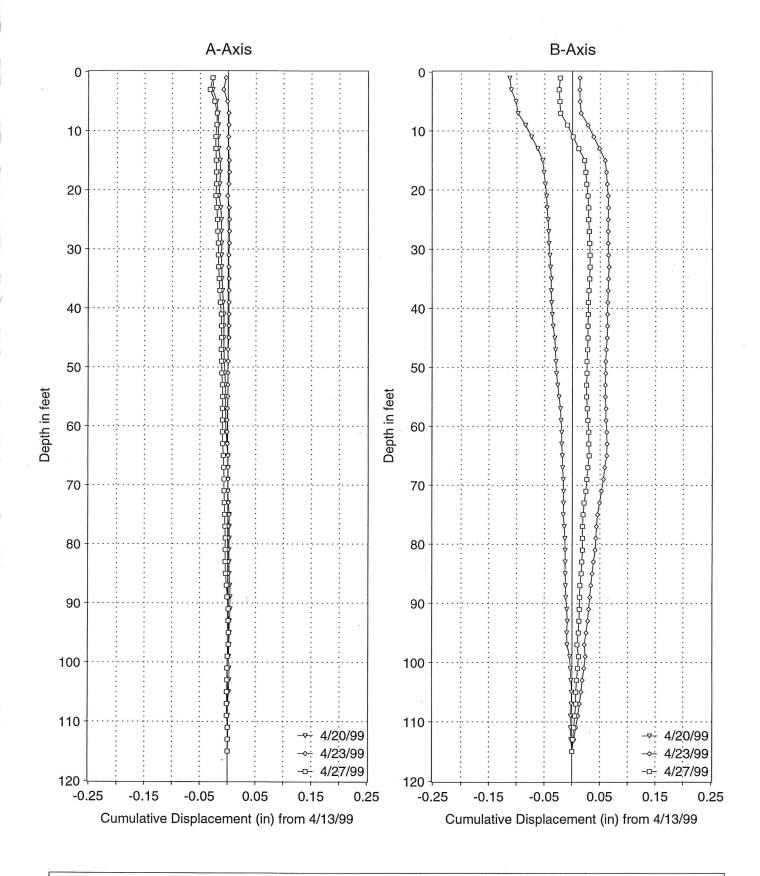
Sunrise Beach Drive
W-8615-02 Fig. C-1

Inclinometer Casing B-1 SHANNON & WILSON, INC.

C-1	Inclinometer Casing B-1
C-2	Inclinometer Casing B-2
C-3	Inclinometer Casing B-3
C-4	Inclinometer Casing B-4

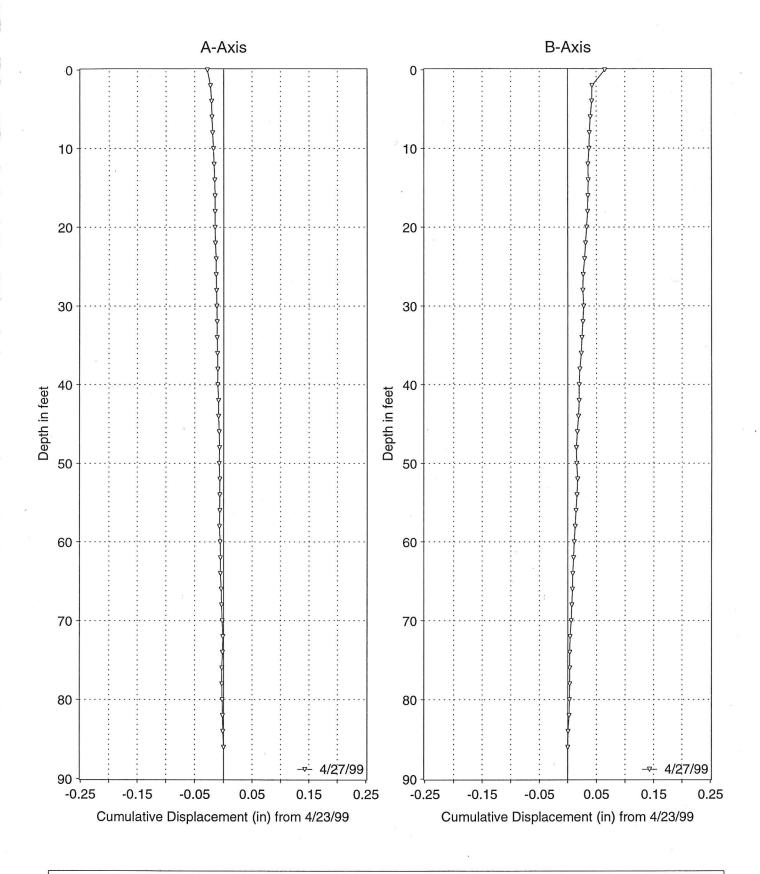
Fig. C-4

Inclinometer Casing B-4

Sunrise Beach Drive
W-8615-02
