## What are the conditions in the North Schneider Sub-watershed?

### Current conditions

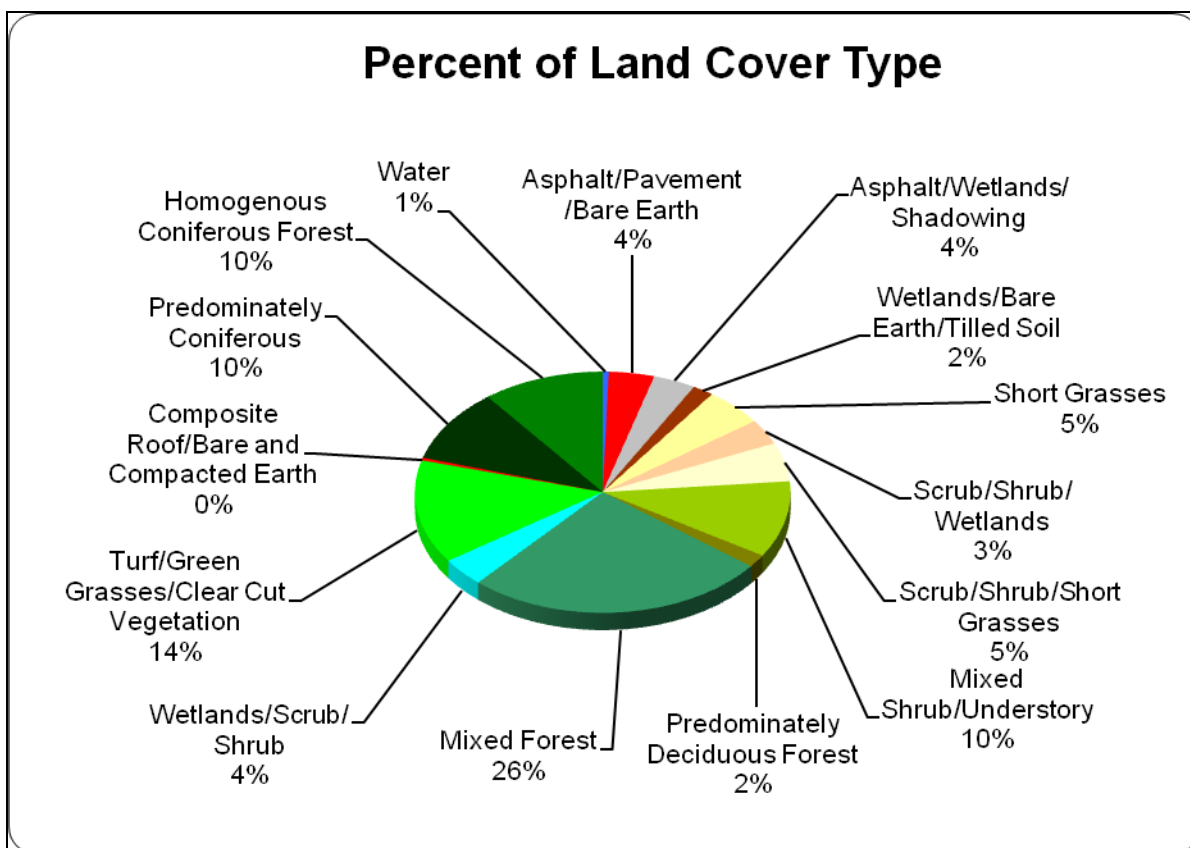
Figure 11a. Classification Percent Totals for North Schneider Sub-watershed

Land cover data from 2005 SPOT imagery.

Approximately four percent of the North Schneider Sub-watershed is covered by urban land uses (see Figure 11 and 11a, Classification Percent Totals for North Schneider Sub-watershed). North Schneider basin has a drainage area of 6.5 square miles.
