# What are the conditions in the North Eld Sub-watershed?

Totten and Eld Inlets Watershed Characterization Report Page 111

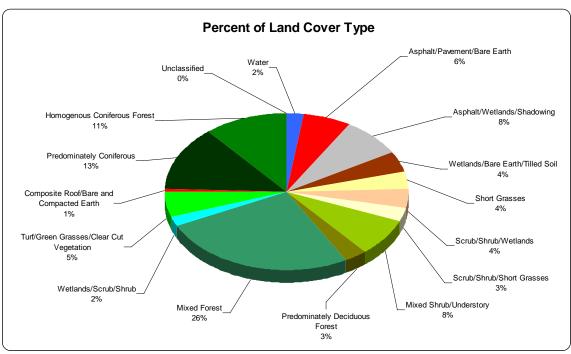
Figure 46a. Classification Percent Totals for North Eld Sub-watershed

Land cover data from 2005 SPOT imagery.

Approximately seven percent of the North Eld Sub-watershed is covered by urban land uses (see Figure 46 and 46a, Classification Percent Totals for North Eld Sub-watershed). North Eld has a drainage area of 0.9 square miles.
