## **What are the conditions in the Mud Bay Sub-watershed?**

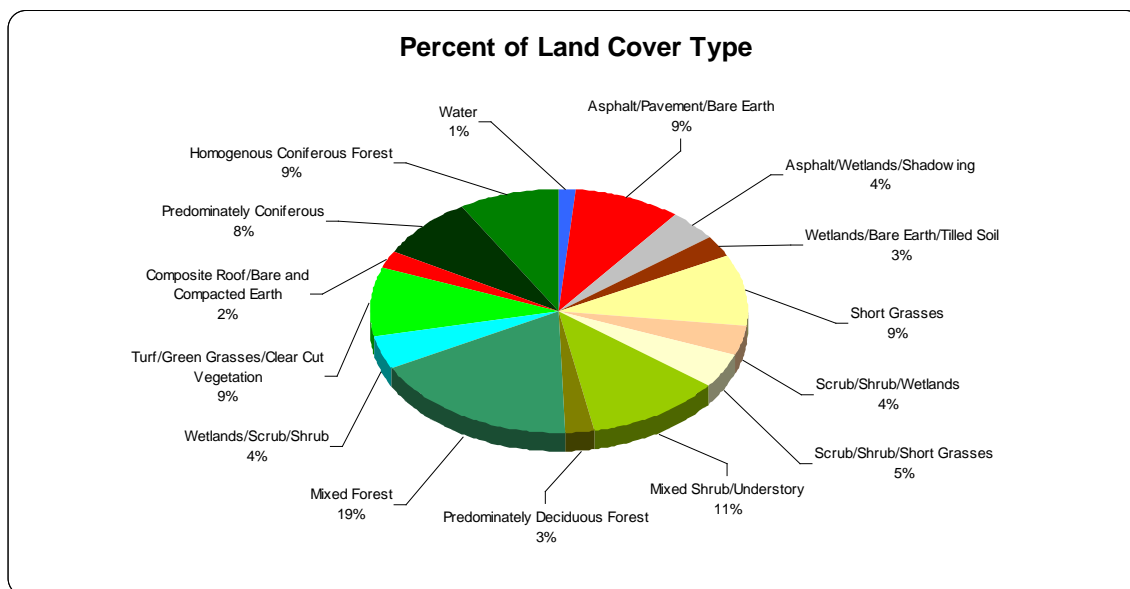
Figure 61a. Classification Percent Totals for Mud Bay Sub-watershed

Land cover data from 2005 SPOT imagery.

Approximately eleven percent of the Mud Bay Sub-watershed is covered by urban land uses (see Figure 61 and 61a. Classification Percent Totals for Mud Bay Sub-watershed). Mud Bay has a drainage area of 3.7 square miles.
